Access Compliance Report

Public Rights-of-Way

(Curb Ramps)

Intersection ID: 13249	Main Street: E_PALMER_ST	Cross Street: S_COLLEGE_ST	Location: SW
ADA ID: 69EFC4E4B28E	Ramp Type: PerpDiag	Initial Pass/Fail: Fail	Overall Compliance: No
Severity Score: 50			
Codes/Mitigation Info/Possible Solution		Field Measurements/Component Compliance

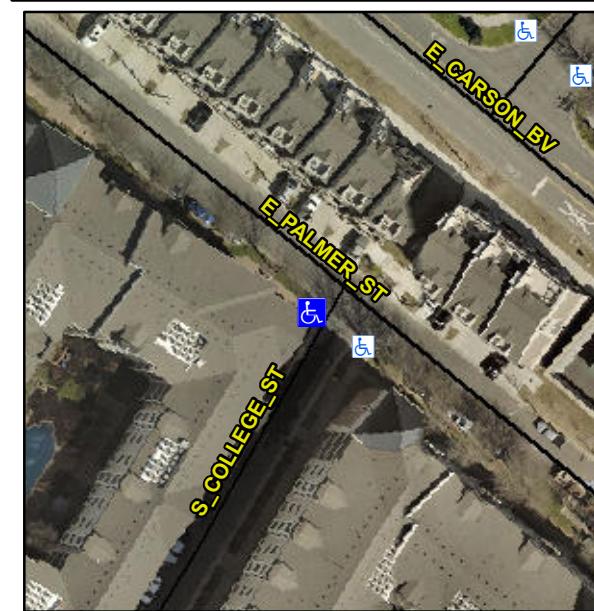
Compliance	Description	Data	Compliance	Description	Data
N/A	Ramp Length (in)	48.0	No	Ramp Slope (%)	13.0
Yes	Ramp Width (in)	48.0	No	Ramp XSlope (%)	7.9
N/A	Flare Type LT	N/A	N/A	Flare Type RT	N/A
N/A	Flare Slope LT (%)	N/A	N/A	Flare Slope RT (%)	N/A
N/A	Flare Traversable LT?	N/A	N/A	Flare Traversable RT?	N/A
N/A	Landing Length (in)	N/A	N/A	DWS Provided?	N/A
N/A	Landing Width (in)	N/A	N/A	DWS Contrast?	N/A
N/A	Landing Slope (%)	N/A	N/A	DWS Length (in)	N/A
N/A	Landing X Slope (%)	N/A	N/A	DWS Full Width?	N/A
N/A	Landing Curb? (Y/N)	N/A	N/A	DWS Offset (in)	N/A
N/A	Shared Landing?	N/A			
N/A	Gutter Ponding?	N/A	N/A	Gutter Slope (%)	N/A
N/A	Gutter Lip Ht (in)	N/A	N/A	Gutter X Slope (%)	N/A
N/A	Painted X Walk1?	No	N/A	Painted X Walk2?	No
	X Walk 1 Direction	To SE		X Walk 2 Direction	To NE
N/A	X Walk 1 Width (in)	N/A	N/A	X Walk 2 Width (in)	N/A
	X Walk 1 Slope (%)	3.7		X Walk 2 Slope (%)	0.7
	X Walk 1 X Slope (%)	3.9		X Walk 2 X Slope (%)	5.1

N/A	Ramp inside XWalk1?	N/A	N/A	Ramp inside XWalk2?	N/A
	Road Slope (%)	8.8	N/A	Clear Space?	N/A
	Road X Slope (%)	1.6	N/A	Clear Space to XWalk (in)	N/A
N/A	Any Obstructions?	N/A	N/A	Storm Grate/Utility Hazard?	N/A
	Obstruction Type			Storm Grate/Utility Type	
		N/A			N/A
		Yes		Surface Condition? (G/P)	Good

Possible Solutions:

Remove & Replace Curb Ramp With Two New Directional Ramps or Equivalent.

PROW/ADA:

R304.2.2, R304.5.3
