## Access Compliance Report Public Rights-of-Way (Curb Ramps)

Intersection ID: 19805 Main Street: MORRISON\_BV Cross Street: SOUTH\_PARK\_DR Location: NW

ADA ID: 69F2A9D43E0B Ramp Type: ParaDiag Initial Pass/Fail: Pass Overall Compliance: No Severity Score: 0

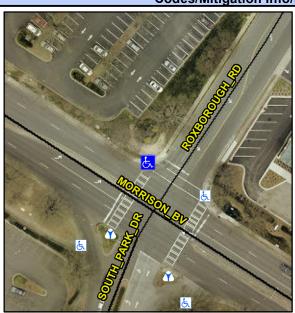
LT RP < 5%

Not Found, R304.5.3

11/7	rtamp Longui Li (iii)	00.0	17/7	rtamp Longui Iti (m)	11.5
Yes	Ramp Width LT (in)	49.5	Yes	Ramp Width RT (in)	49.0
Yes	Ramp Slope LT (%)	1.6	Yes	Ramp Slope RT (%)	7.3
Yes	Ramp XSlope LT (%)	0.3	Yes	Ramp XSlope RT (%)	1.4
Yes	Landing Length (in)	48.0	Yes	DWS Provided?	Yes
Yes	Landing Width (in)	60.0	Yes	DWS Contrast?	Yes
Yes	Landing Slope (%)	1.3	Yes	DWS Length (in)	24.0
Yes	Landing X Slope (%)	1.5	Yes	DWS Full Width?	Yes
N/A	Landing Curb? (Y/N)	No	Yes	DWS Offset (in)	0.0
N/A	Shared Landing?	No			
Yes	Gutter Ponding?	No	Yes	Gutter Slope (%)	2.0
Yes	Gutter Lip Ht (in)	0.0	No	Gutter X Slope (%)	2.7
N/A	Painted X Walk1?	Yes	N/A	Painted X Walk2?	Yes
	X Walk 1 Direction	To SW		X Walk 2 Direction	To SE
N/A	X Walk 1 Width (in)	111.0	N/A	X Walk 2 Width (in)	111.0
	X Walk 1 Slope (%)	0.6		X Walk 2 Slope (%)	1.7
	X Walk 1 X Slope (%)	1.5		X Walk 2 X Slope (%)	0.0
Yes	Ramp inside XWalk1?	Yes	Yes	Ramp inside XWalk2?	Yes

Road Slope (%)	2.1	N/A	Clear Space?	Yes
	Road X Slope (%)	1.4	Yes	Clear Space to XWalk (in)	104.0
Yes	Any Obstructions?	No	Yes	Storm Grate/Utility Hazard?	No
	Obstruction Type			Storm Grate/Utility Type	
		N/A			N/A
			Yes	Surface Condition? (G/P)	Good
			Replace Curb Siloppe (%)		8.6

MORRISON BV Signal ROXBOROUGH RD Signal Remove & Replace Curb Slope and Extend Ramp. Remove & Replace Gutter.

Total Cost: \$ 2750.00
