# Access Compliance Report

## Public Rights-of-Way

### (Curb Ramps)

Intersection ID: 49277	Main Street: REUNION_ST	Cross Street: HOMECOMING_WY	Location: SE
ADA ID: 69F41094393D	Ramp Type: PerpDiag	Initial Pass/Fail: Fail	Overall Compliance: No
		Severity Score: 25

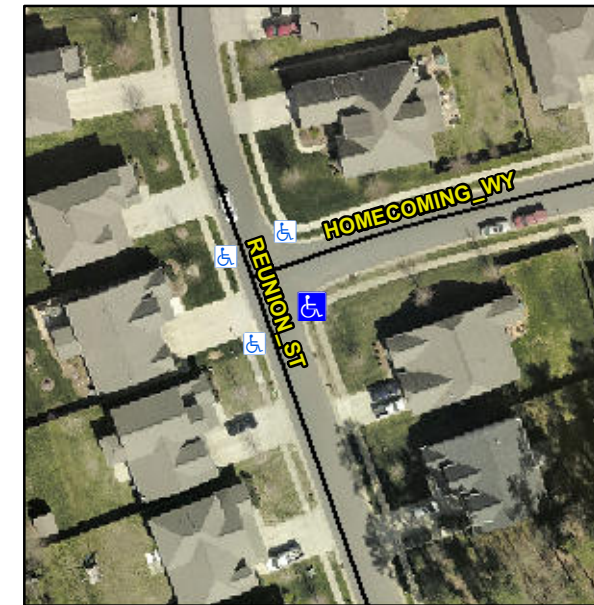
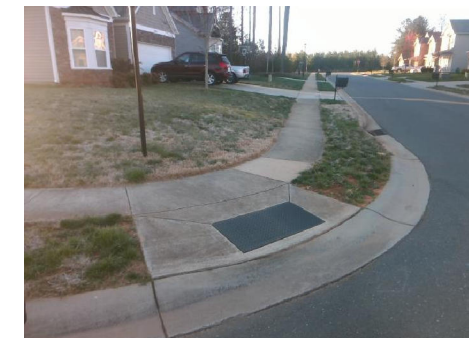
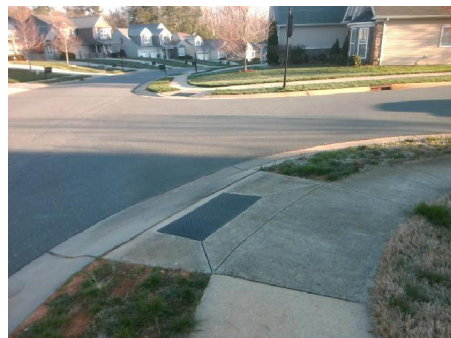
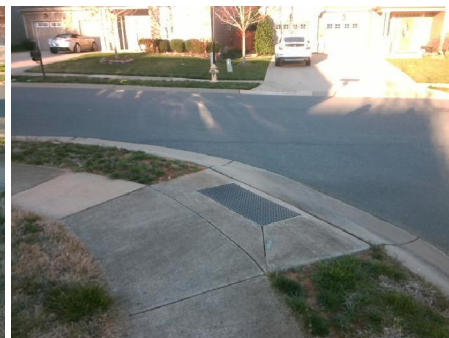
Compliance	Description	Data	Compliance	Description	Data
N/A	Ramp Length (in)	46.0	No	Ramp Slope (%)	12.9
Yes	Ramp Width (in)	48.0	Yes	Ramp XSlope (%)	0.4
N/A	Flare Type LT	N/A	N/A	Flare Type RT	N/A
N/A	Flare Slope LT (%)	N/A	N/A	Flare Slope RT (%)	N/A
N/A	Flare Traversable LT?	N/A	N/A	Flare Traversable RT?	N/A
N/A	Landing Length (in)	N/A	N/A	DWS Provided?	N/A
N/A	Landing Width (in)	N/A	N/A	DWS Contrast?	N/A
N/A	Landing Slope (%)	N/A	N/A	DWS Length (in)	N/A
N/A	Landing X Slope (%)	N/A	N/A	DWS Full Width?	N/A
N/A	Landing Curb? (Y/N)	N/A	N/A	DWS Offset (in)	N/A
N/A	Shared Landing?	N/A			
N/A	Gutter Ponding?	N/A	N/A	Gutter Slope (%)	N/A
N/A	Gutter Lip Ht (in)	N/A	N/A	Gutter X Slope (%)	N/A
N/A	Painted X Walk1?	No	N/A	Painted X Walk2?	No
	X Walk 1 Direction	To N		X Walk 2 Direction	To W
N/A	X Walk 1 Width (in)	N/A	N/A	X Walk 2 Width (in)	N/A
	X Walk 1 Slope (%)	0.1		X Walk 2 Slope (%)	1.3
	X Walk 1 X Slope (%)	0.4		X Walk 2 X Slope (%)	1.2

N/A	Ramp inside XWalk1?	N/A	N/A	Ramp inside XWalk2?	N/A
	Road Slope (%)	1.7	N/A	Clear Space?	N/A
	Road X Slope (%)	0.4	N/A	Clear Space to XWalk (in)	N/A
N/A	Any Obstructions?	N/A	N/A	Storm Grate/Utility Hazard?	N/A
	Obstruction Type			Storm Grate/Utility Type	
		N/A			N/A
			Yes	Surface Condition? (G/P)	Good

**Remove & Replace Curb Ramp With Two New Directional Ramps or Equivalent.**

**R304.2.2**

**\$ 3200.00**
