Access Compliance Report

Public Rights-of-Way

(Curb Ramps)

Intersection ID: 47611	Main Street: WYALONG_DR	Cross Street: MINTWORTH_AV	Location: NE
ADA ID: 69FAA85AD425	Ramp Type: Perp	Initial Pass/Fail: Fail	Overall Compliance: No
		Severity Score: 12.5

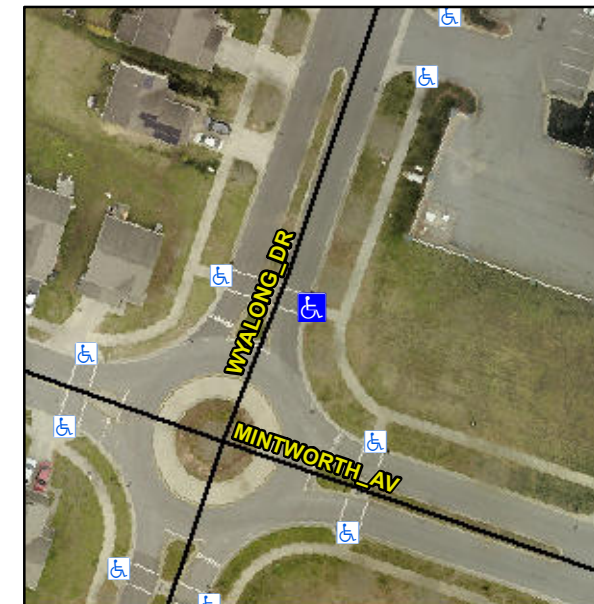
Compliance	Description	Data	Compliance	Description	Data
N/A	Ramp Length (in)	180.0	No	Ramp Slope (%)	8.7
Yes	Ramp Width (in)	74.0	Yes	Ramp XSlope (%)	0.9
N/A	Flare Type LT	N/A	N/A	Flare Type RT	N/A
N/A	Flare Slope LT (%)	N/A	N/A	Flare Slope RT (%)	N/A
N/A	Flare Traversable LT?	N/A	N/A	Flare Traversable RT?	N/A
N/A	Landing Length (in)	N/A	N/A	DWS Provided?	N/A
N/A	Landing Width (in)	N/A	N/A	DWS Contrast?	N/A
N/A	Landing Slope (%)	N/A	N/A	DWS Length (in)	N/A
N/A	Landing X Slope (%)	N/A	N/A	DWS Full Width?	N/A
N/A	Landing Curb? (Y/N)	N/A	N/A	DWS Offset (in)	N/A
N/A	Shared Landing?	N/A			
N/A	Gutter Ponding?	N/A	N/A	Gutter Slope (%)	N/A
N/A	Gutter Lip Ht (in)	N/A	N/A	Gutter X Slope (%)	N/A
N/A	Painted X Walk1?	Yes	N/A	Painted X Walk2?	N/A
	X Walk 1 Direction	To NW		X Walk 2 Direction	N/A
N/A	X Walk 1 Width (in)	119.0	N/A	X Walk 2 Width (in)	N/A
	X Walk 1 Slope (%)	5.8		X Walk 2 Slope (%)	N/A
	X Walk 1 X Slope (%)	1.0		X Walk 2 X Slope (%)	N/A

N/A	Ramp inside XWalk1?	Yes	N/A	Ramp inside XWalk2?	N/A
	Road Slope (%)	N/A	N/A	Clear Space?	N/A
	Road X Slope (%)	N/A	N/A	Clear Space to XWalk (in)	N/A
N/A	Any Obstructions?	N/A	N/A	Storm Grate/Utility Hazard?	N/A
	Obstruction Type			Storm Grate/Utility Type	
		N/A			N/A
			Yes	Surface Condition? (G/P)	Good

Remove & Replace Entire Ramp.
