Access Compliance Report

Public Rights-of-Way

(Curb Ramps)

Intersection ID: 10032938	Main Street: NEW_BERN_ST	Cross Street: N/A	Location: SW
ADA ID: 69FEE6D5A8EE	Ramp Type: Perp	Initial Pass/Fail: Fail	Overall Compliance: No
Severity Score: 12.5			
Codes/Mitigation Info/Possible Solution		Field Measurements/Component Compliance

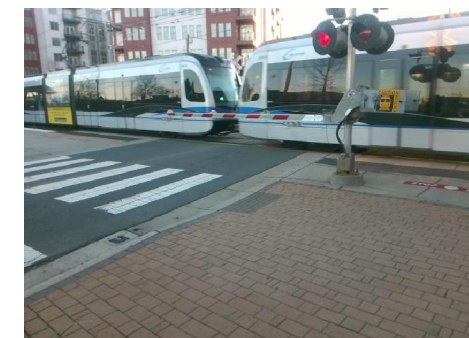
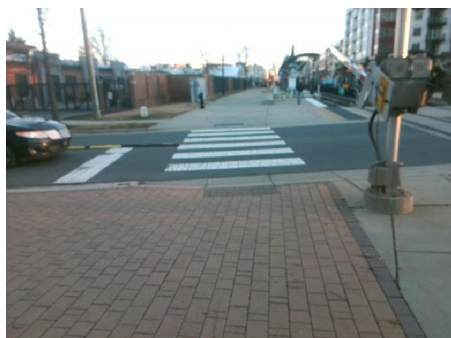
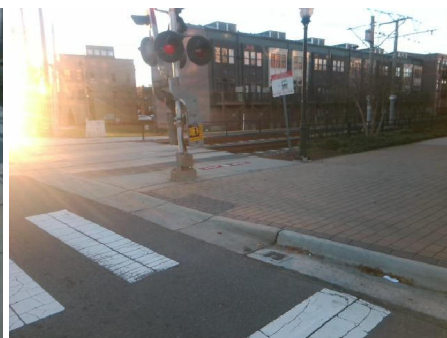
Compliance	Description	Data	Compliance	Description	Data
N/A	Ramp Length (in)	48.0	Yes	Ramp Slope (%)	5.8
Yes	Ramp Width (in)	48.0	No	Ramp XSlope (%)	6.9
N/A	Flare Type LT	N/A	N/A	Flare Type RT	N/A
N/A	Flare Slope LT (%)	N/A	N/A	Flare Slope RT (%)	N/A
N/A	Flare Traversable LT?	N/A	N/A	Flare Traversable RT?	N/A
N/A	Landing Length (in)	N/A	N/A	DWS Provided?	N/A
N/A	Landing Width (in)	N/A	N/A	DWS Contrast?	N/A
N/A	Landing Slope (%)	N/A	N/A	DWS Length (in)	N/A
N/A	Landing X Slope (%)	N/A	N/A	DWS Full Width?	N/A
N/A	Landing Curb? (Y/N)	N/A	N/A	DWS Offset (in)	N/A
N/A	Shared Landing?	N/A			
N/A	Gutter Ponding?	N/A	N/A	Gutter Slope (%)	N/A
N/A	Gutter Lip Ht (in)	N/A	N/A	Gutter X Slope (%)	N/A
N/A	Painted X Walk1?	Yes	N/A	Painted X Walk2?	N/A
	X Walk 1 Direction	To NE		X Walk 2 Direction	N/A
N/A	X Walk 1 Width (in)	119.0	N/A	X Walk 2 Width (in)	N/A
	X Walk 1 Slope (%)	1.2		X Walk 2 Slope (%)	N/A
	X Walk 1 X Slope (%)	3.5		X Walk 2 X Slope (%)	N/A

N/A	Ramp inside XWalk1?	Yes	N/A	Ramp inside XWalk2?	N/A
	Road Slope (%)	N/A	N/A	Clear Space?	N/A
	Road X Slope (%)	N/A	N/A	Clear Space to XWalk (in)	N/A
N/A	Any Obstructions?	N/A	N/A	Storm Grate/Utility Hazard?	N/A
	Obstruction Type			Storm Grate/Utility Type	
		N/A			N/A
		Yes		Surface Condition? (G/P)	Good

Possible Solutions:

Remove & Replace Entire Ramp.
