# Access Compliance Report

## Public Rights-of-Way

### (Curb Ramps)

| Intersection ID: 23898 | Main Street: LONGHEDGE_LN | Cross Street: MOSS_RD | Location: SW |

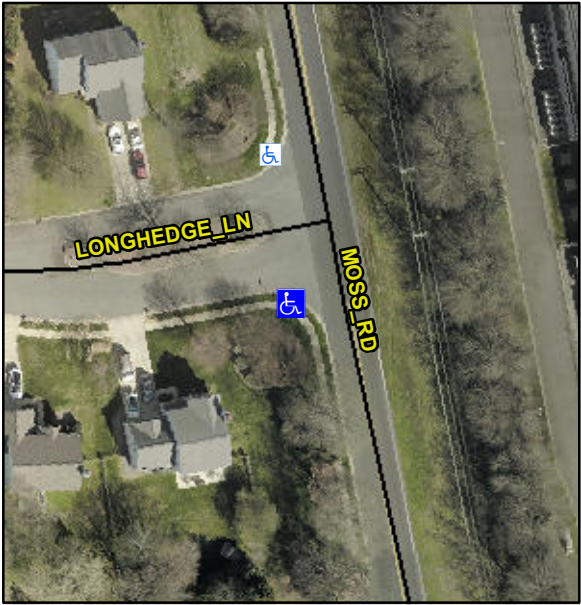
| ADA ID: 6A0ABD53C618 | Ramp Type: PerpDiag | Initial Pass/Fail: Fail | Overall Compliance: No |

| | Remove & Replace Curb Ramp With Two New Directional Ramps or Equivalent. | N/A | Ramp Length (in) | 47.0 | No | Ramp Slope (%) | 8.6 |
| <p>Surveyor Notes:</p> <p>N/A</p> <p>PROW/ADA:</p> <p>Not Found, R304.2.2</p> | | N/A | Landing Curb? (Y/N) | N/A | N/A | DWS Offset (in) | N/A |
