# Access Compliance Report

## Public Rights-of-Way

### (Curb Ramps)

| Intersection ID: 24485 | Main Street: CAMAROSS_DR | Cross Street: SAINTFIELD_PL | Location: SW |

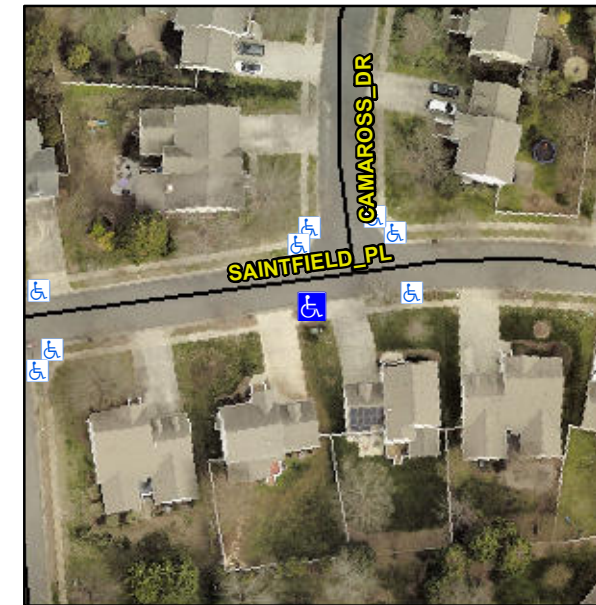
| ADA ID: 6A1275D7A2F4 | Ramp Type: Perp | Initial Pass/Fail: Pass | Overall Compliance: No |
| | | Severity Score: 7.5 | |

| Compliance | Description | Data | Compliance | Description | Data |
|---|---|---|---|---|---|
| No | Landing Length (in) | 47.0 | Yes | DWS Provided? | Yes |
| No | Landing Slope (%) | 3.9 | Yes | DWS Length (in) | 24.0 |
| Yes | Landing X Slope (%) | 0.5 | No | DWS Full Width? | No |
| Yes | Gutter Ponding? | No | No | Gutter Slope (%) | 9.3 |

**Remove & Replace Entire Ramp.  
Remove & Replace Gutter.**

Total Cost: \$ 2600.00
