Access Compliance Report

Public Rights-of-Way

(Curb Ramps)

Intersection ID: N/A	Main Street: TAMARACK DR	Cross Street: SINGLELEAF LN	Location: W
ADA ID: 6A15BB4D2306	Ramp Type: Perp	Initial Pass/Fail: Pass	Overall Compliance: No
Severity Score: 0			
Codes/Mitigation Info/Possible Solution		Field Measurements/Component Compliance

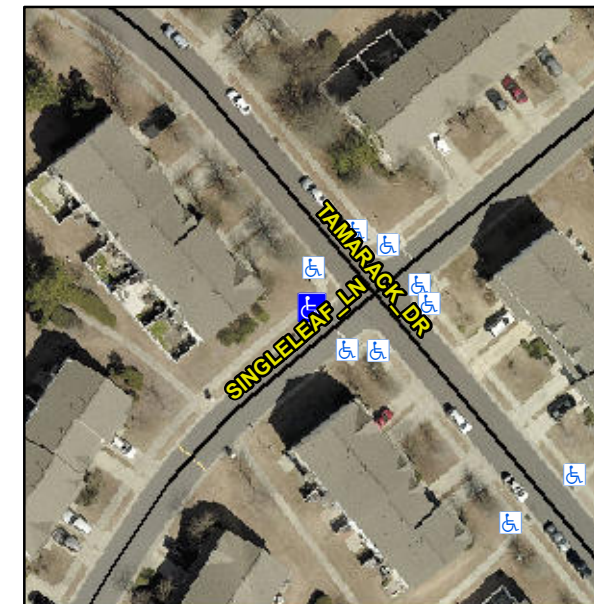
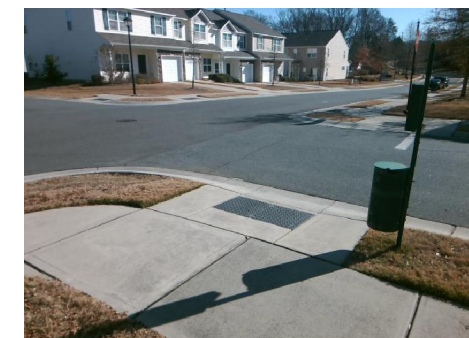
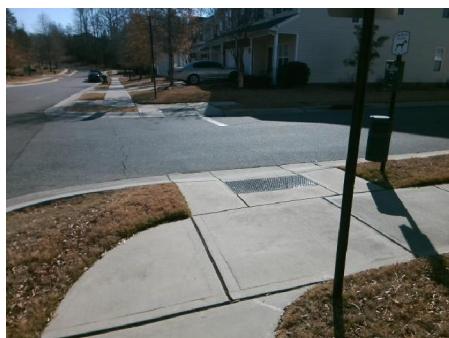
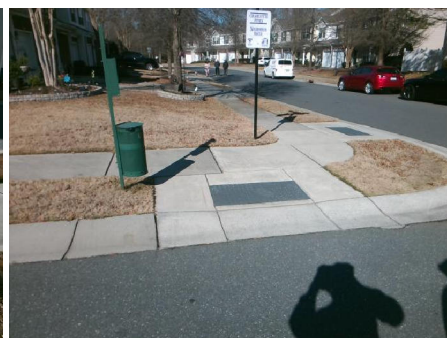
Not Found, R305.2

Compliance	Description	Data	Compliance	Description	Data
N/A	Ramp Length (in)	47.0	Yes	Ramp Slope (%)	6.6
Yes	Ramp Width (in)	48.0	Yes	Ramp XSlope (%)	1.7
N/A	Flare Type LT	Sloped	N/A	Flare Type RT	N/A
N/A	Flare Slope LT (%)	6.6	N/A	Flare Slope RT (%)	4.9
N/A	Flare Traversable LT?	No	N/A	Flare Traversable RT?	No
Yes	Landing Length (in)	60.0	Yes	DWS Provided?	Yes
Yes	Landing Width (in)	48.0	Yes	DWS Contrast?	Yes
Yes	Landing Slope (%)	1.3	Yes	DWS Length (in)	24.0
Yes	Landing X Slope (%)	1.5	Yes	DWS Full Width?	Yes
N/A	Landing Curb? (Y/N)	No	No	DWS Offset (in)	4.5
N/A	Shared Landing?	No			
Yes	Gutter Ponding?	No	Yes	Gutter Slope (%)	1.9
Yes	Gutter Lip Ht (in)	0.0	Yes	Gutter X Slope (%)	1.2
N/A	Painted X Walk1?	No	N/A	Painted X Walk2?	N/A
	X Walk 1 Direction	To SE		X Walk 2 Direction	N/A
N/A	X Walk 1 Width (in)	N/A	N/A	X Walk 2 Width (in)	N/A
	X Walk 1 Slope (%)	2.2		X Walk 2 Slope (%)	N/A
	X Walk 1 X Slope (%)	1.1		X Walk 2 X Slope (%)	N/A

N/A	Ramp inside XWalk1?	No	N/A	Ramp inside XWalk2?	N/A
	Road Slope (%)	N/A	N/A	Clear Space?	Yes
	Road X Slope (%)	N/A	N/A	Clear Space to XWalk (in)	N/A
Yes	Any Obstructions?	No	Yes	Storm Grate/Utility Hazard?	No
	Obstruction Type			Storm Grate/Utility Type	
		N/A			N/A
			Yes	Surface Condition? (G/P)	Good

Possible Solutions:

Remove & Replace Entire Ramp.
