# Access Compliance Report

## Public Rights-of-Way (Curb Ramps)

Intersection ID: 14566	Main Street: PROVIDENCE_RD	Cross Street: S_COLONIAL_AV	Location: SW
ADA ID: 6A2B65D7467F	Ramp Type: PerpDiag	Initial Pass/Fail: Fail	Overall Compliance: No Severity Score: 13.75

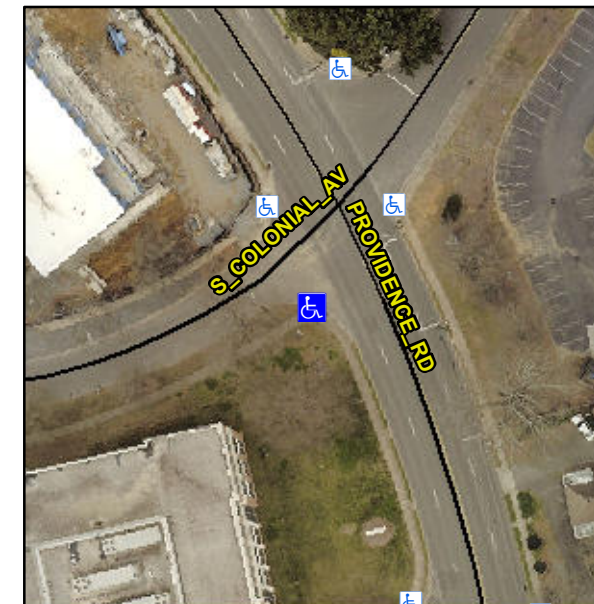
Compliance	Description	Data	Compliance	Description	Data
N/A	Ramp Length (in)	84.0	No	Ramp Slope (%)	8.9
Yes	Ramp Width (in)	48.0	No	Ramp XSlope (%)	2.3
N/A	Flare Type LT	N/A	N/A	Flare Type RT	N/A
N/A	Flare Slope LT (%)	N/A	N/A	Flare Slope RT (%)	N/A
N/A	Flare Traversable LT?	N/A	N/A	Flare Traversable RT?	N/A
N/A	Landing Length (in)	N/A	N/A	DWS Provided?	N/A
N/A	Landing Width (in)	N/A	N/A	DWS Contrast?	N/A
N/A	Landing Slope (%)	N/A	N/A	DWS Length (in)	N/A
N/A	Landing X Slope (%)	N/A	N/A	DWS Full Width?	N/A
N/A	Landing Curb? (Y/N)	N/A	N/A	DWS Offset (in)	N/A
N/A	Shared Landing?	N/A			
N/A	Gutter Ponding?	N/A	N/A	Gutter Slope (%)	N/A
N/A	Gutter Lip Ht (in)	N/A	N/A	Gutter X Slope (%)	N/A
N/A	Painted X Walk1?	No	N/A	Painted X Walk2?	No
	X Walk 1 Direction	To NE		X Walk 2 Direction	To N
N/A	X Walk 1 Width (in)	N/A	N/A	X Walk 2 Width (in)	N/A
	X Walk 1 Slope (%)	1.6		X Walk 2 Slope (%)	3.5
	X Walk 1 X Slope (%)	3.6		X Walk 2 X Slope (%)	3.7

N/A	Ramp inside XWalk1?	N/A	N/A	Ramp inside XWalk2?	N/A
	Road Slope (%)	0.3	N/A	Clear Space?	N/A
	Road X Slope (%)	5.1	N/A	Clear Space to XWalk (in)	N/A
N/A	Any Obstructions?	N/A	N/A	Storm Grate/Utility Hazard?	N/A
	Obstruction Type			Storm Grate/Utility Type	
		N/A			N/A
			Yes	Surface Condition? (G/P)	Good

**Remove & Replace Curb Ramp With Two New Directional Ramps or Equivalent.**

**R304.2.2, R304.5.3**
