# Access Compliance Report

## Public Rights-of-Way

### (Curb Ramps)

| Intersection ID: 29795 | Main Street: BRISTLE_TOE_LN | Cross Street: CHELTON_RIDGE_LN | Location: SE |

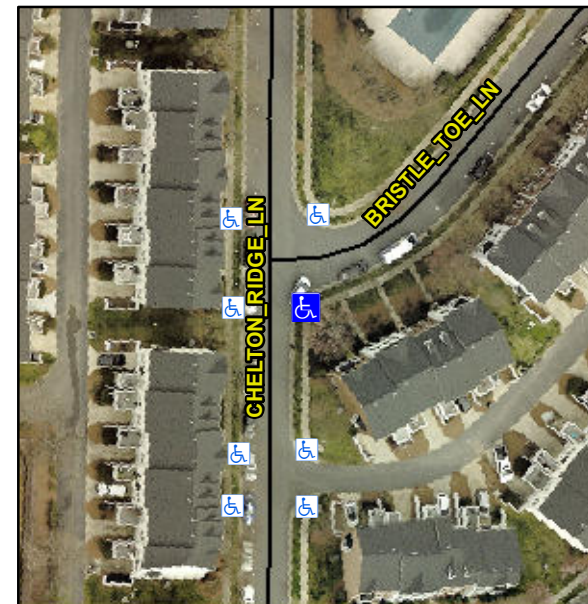
| ADA ID: 6A3C2DEC311E | Ramp Type: PerpDiag | Initial Pass/Fail: Fail | Overall Compliance: No |

| Compliance | Description | Data | Compliance | Description | Data |
|---|---|---|---|---|---|
| N/A | Ramp Length (in) | 96.0 | No | Ramp Slope (%) | 10.8 |
| No | Ramp Width (in) | 33.0 | No | Ramp XSlope (%) | 2.1 |

**Remove & Replace Curb Ramp With Two New Directional Ramps or Equivalent.**

**R304.5.1, R304.2.2, R304.5.3**
