Access Compliance Report

Public Rights-of-Way

(Curb Ramps)

Intersection ID: 43648	Main Street: CAMDEN_MEADOW_DR	Cross Street: SWANN_BRANCH_DR	Location: SE
ADA ID: 6A3D5C4305E4	Ramp Type: PerpDiag	Initial Pass/Fail: Fail	Overall Compliance: No
Severity Score: 21.25			
Codes/Mitigation Info/Possible Solution		Field Measurements/Component Compliance

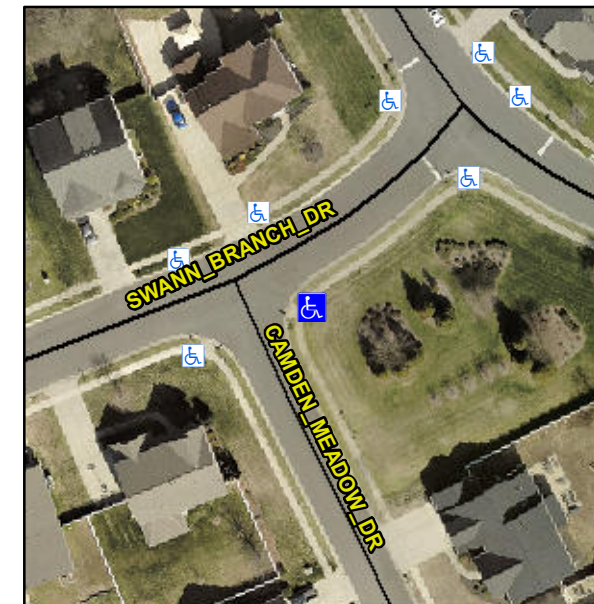
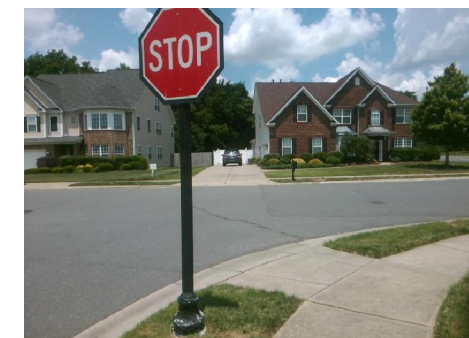
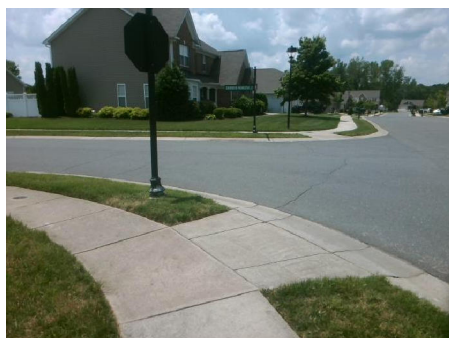
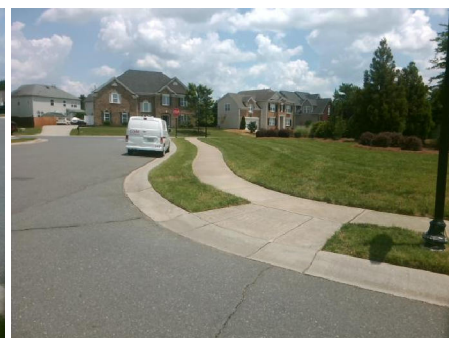
Not Found, R304.5.1, R304.2.2

Compliance	Description	Data	Compliance	Description	Data
N/A	Ramp Length (in)	52.0	No	Ramp Slope (%)	8.4
No	Ramp Width (in)	37.0	Yes	Ramp XSlope (%)	0.3
N/A	Flare Type LT	N/A	N/A	Flare Type RT	N/A
N/A	Flare Slope LT (%)	N/A	N/A	Flare Slope RT (%)	N/A
N/A	Flare Traversable LT?	N/A	N/A	Flare Traversable RT?	N/A
N/A	Landing Length (in)	N/A	N/A	DWS Provided?	N/A
N/A	Landing Width (in)	N/A	N/A	DWS Contrast?	N/A
N/A	Landing Slope (%)	N/A	N/A	DWS Length (in)	N/A
N/A	Landing X Slope (%)	N/A	N/A	DWS Full Width?	N/A
N/A	Landing Curb? (Y/N)	N/A	N/A	DWS Offset (in)	N/A
N/A	Shared Landing?	N/A			
N/A	Gutter Ponding?	N/A	N/A	Gutter Slope (%)	N/A
N/A	Gutter Lip Ht (in)	N/A	N/A	Gutter X Slope (%)	N/A
N/A	Painted X Walk1?	No	N/A	Painted X Walk2?	No
	X Walk 1 Direction	To N		X Walk 2 Direction	To W
N/A	X Walk 1 Width (in)	N/A	N/A	X Walk 2 Width (in)	N/A
	X Walk 1 Slope (%)	4.4		X Walk 2 Slope (%)	0.5
	X Walk 1 X Slope (%)	0.4		X Walk 2 X Slope (%)	2.1

N/A	Ramp inside XWalk1?	N/A	N/A	Ramp inside XWalk2?	N/A
	Road Slope (%)	0.5	N/A	Clear Space?	N/A
	Road X Slope (%)	1.8	N/A	Clear Space to XWalk (in)	N/A
N/A	Any Obstructions?	N/A	N/A	Storm Grate/Utility Hazard?	N/A
	Obstruction Type			Storm Grate/Utility Type	
		N/A			N/A
		Yes		Surface Condition? (G/P)	Good

Remove & Replace Curb Ramp With Two New Directional Ramps or Equivalent.

Total Cost: \$ 3200.00
