Access Compliance Report

Public Rights-of-Way

(Curb Ramps)

Intersection ID: 10031842	Main Street: MINTWORTH_AV	Cross Street: N/A	Location: SW
ADA ID: 6A4AF56DFEA2	Ramp Type: Perp	Initial Pass/Fail: Fail	Overall Compliance: No
			Severity Score: 25

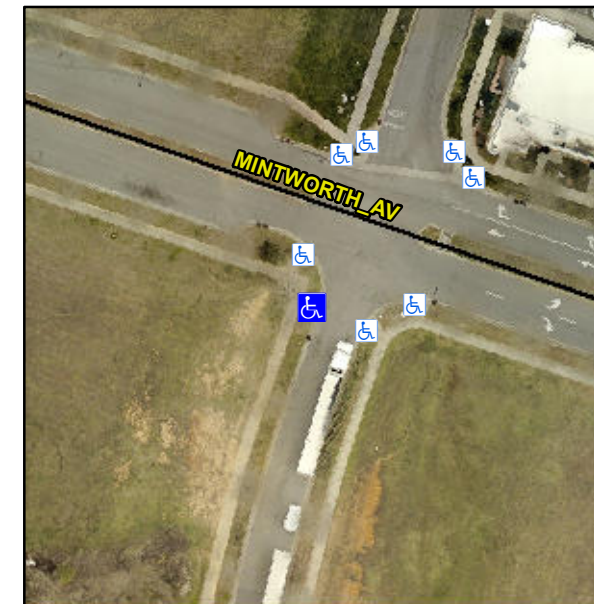
R304.2.2, R304.5.3

Compliance	Description	Data	Compliance	Description	Data
N/A	Ramp Length (in)	101.0	No	Ramp Slope (%)	8.5
Yes	Ramp Width (in)	48.0	No	Ramp XSlope (%)	5.6
N/A	Flare Type LT	N/A	N/A	Flare Type RT	N/A
N/A	Flare Slope LT (%)	N/A	N/A	Flare Slope RT (%)	N/A
N/A	Flare Traversable LT?	N/A	N/A	Flare Traversable RT?	N/A
N/A	Landing Length (in)	N/A	N/A	DWS Provided?	N/A
N/A	Landing Width (in)	N/A	N/A	DWS Contrast?	N/A
N/A	Landing Slope (%)	N/A	N/A	DWS Length (in)	N/A
N/A	Landing X Slope (%)	N/A	N/A	DWS Full Width?	N/A
N/A	Landing Curb? (Y/N)	N/A	N/A	DWS Offset (in)	N/A
N/A	Shared Landing?	N/A			
N/A	Gutter Ponding?	N/A	N/A	Gutter Slope (%)	N/A
N/A	Gutter Lip Ht (in)	N/A	N/A	Gutter X Slope (%)	N/A
N/A	Painted X Walk1?	No	N/A	Painted X Walk2?	N/A
	X Walk 1 Direction	To SE		X Walk 2 Direction	N/A
N/A	X Walk 1 Width (in)	N/A	N/A	X Walk 2 Width (in)	N/A
	X Walk 1 Slope (%)	4.8		X Walk 2 Slope (%)	N/A
	X Walk 1 X Slope (%)	2.6		X Walk 2 X Slope (%)	N/A

N/A	Ramp inside XWalk1?	N/A	N/A	Ramp inside XWalk2?	N/A
	Road Slope (%)	N/A	N/A	Clear Space?	N/A
	Road X Slope (%)	N/A	N/A	Clear Space to XWalk (in)	N/A
N/A	Any Obstructions?	N/A	N/A	Storm Grate/Utility Hazard?	N/A
	Obstruction Type			Storm Grate/Utility Type	
		N/A			N/A
			Yes	Surface Condition? (G/P)	Good

Remove & Replace Entire Ramp.
