Access Compliance Report

Public Rights-of-Way

(Curb Ramps)

Intersection ID: N/A	Main Street: PINEVILLE-MATTHEWS_RD	Cross Street: COURTSIDE_LN	Location: SW
ADA ID: 6A4BC24669F8	Ramp Type: Perp	Initial Pass/Fail: Fail	Overall Compliance: No
Codes/Mitigation Info/Possible Solution			Severity Score: 25
			Field Measurements/Component Compliance

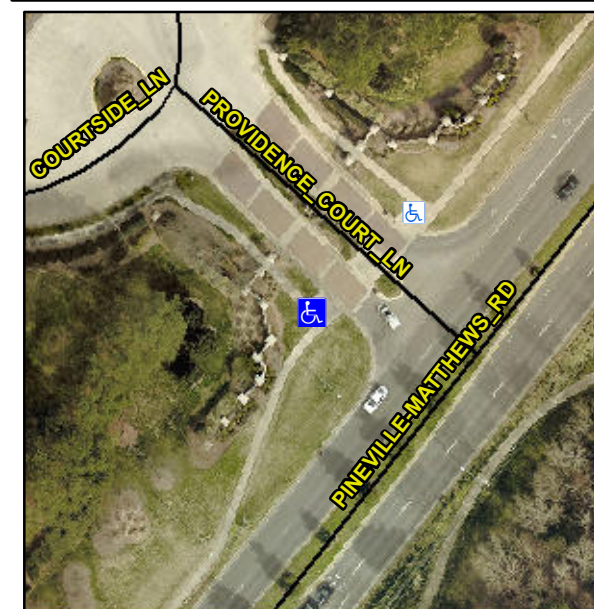
Not Found, R304.2.2

Compliance	Description	Data	Compliance	Description	Data
N/A	Ramp Length (in)	105.0	No	Ramp Slope (%)	12.3
Yes	Ramp Width (in)	56.0	Yes	Ramp XSlope (%)	1.0
N/A	Flare Type LT	N/A	N/A	Flare Type RT	N/A
N/A	Flare Slope LT (%)	N/A	N/A	Flare Slope RT (%)	N/A
N/A	Flare Traversable LT?	N/A	N/A	Flare Traversable RT?	N/A
N/A	Landing Length (in)	N/A	N/A	DWS Provided?	N/A
N/A	Landing Width (in)	N/A	N/A	DWS Contrast?	N/A
N/A	Landing Slope (%)	N/A	N/A	DWS Length (in)	N/A
N/A	Landing X Slope (%)	N/A	N/A	DWS Full Width?	N/A
N/A	Landing Curb? (Y/N)	N/A	N/A	DWS Offset (in)	N/A
N/A	Shared Landing?	N/A			
N/A	Gutter Ponding?	N/A	N/A	Gutter Slope (%)	N/A
N/A	Gutter Lip Ht (in)	N/A	N/A	Gutter X Slope (%)	N/A
N/A	Painted X Walk1?	No	N/A	Painted X Walk2?	N/A
	X Walk 1 Direction	To NE		X Walk 2 Direction	N/A
N/A	X Walk 1 Width (in)	N/A	N/A	X Walk 2 Width (in)	N/A
	X Walk 1 Slope (%)	1.5		X Walk 2 Slope (%)	N/A
	X Walk 1 X Slope (%)	1.8		X Walk 2 X Slope (%)	N/A

Possible Solutions:

Remove & Replace Entire Ramp.
