# Access Compliance Report

## Public Rights-of-Way

| Intersection ID: 28386 | Main Street: MARVIN_RD | Cross Street: SOUTHAMPTON_COMMONS_DR | Location: W |
| ADA ID: 6A540635A819 | Ramp Type: BlendTrans2 | Initial Pass/Fail: Fail | Overall Compliance: No |

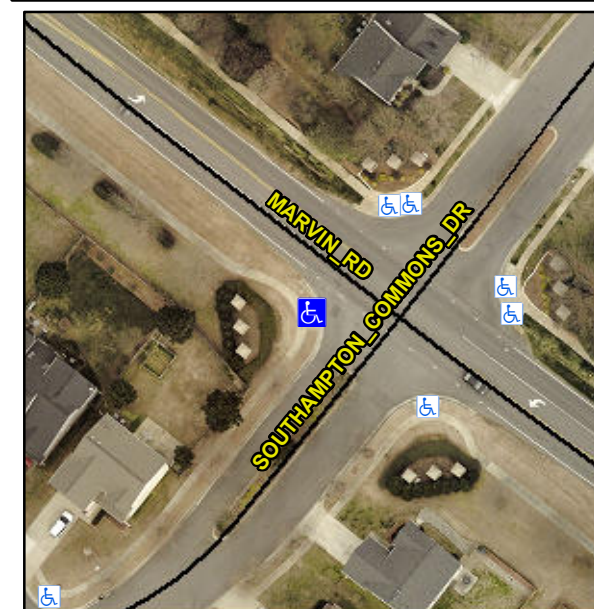
| Severity Score: 47.5 | | | |

**R304.5.1, R304.5.3**

| Compliance | Description | Data | Compliance | Description | Data |
|---|---|---|---|---|---|
| No | Ramp Width (in) | 31.0 | No | BlendTrans XSlope (%) | 6.4 |

**Remove & Replace Curb Ramp With Two New Directional Ramps or Equivalent.**

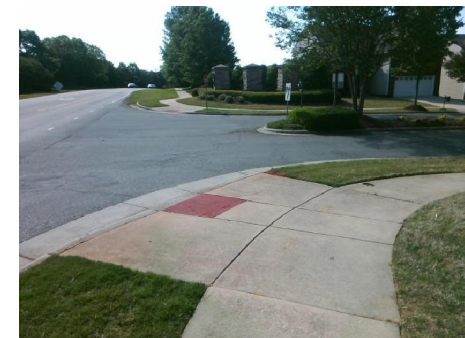
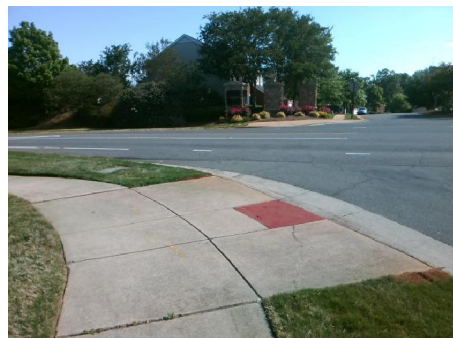
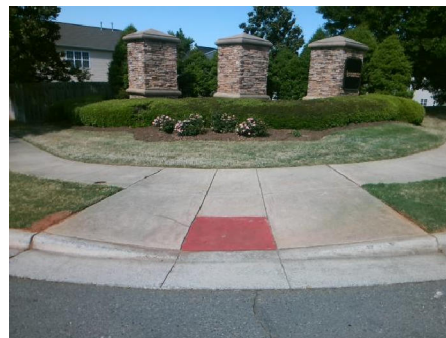
Street 1 Name **SOUTHAMPTON COMMONS DR**  
 Stop Condition-Street 1 **StopSign**  
 Street 2 Name **MARVIN RD**  
 Stop Condition-Street 2 **None**
