# Access Compliance Report

## Public Rights-of-Way

### (Curb Ramps)

Intersection ID: 51310	Main Street: I-485_RA	Cross Street: W_W_T_HARRIS_BV	Location: W
ADA ID: 6A54F6604862	Ramp Type: Perp	Initial Pass/Fail: Fail	Overall Compliance: No
			Severity Score: 21.25

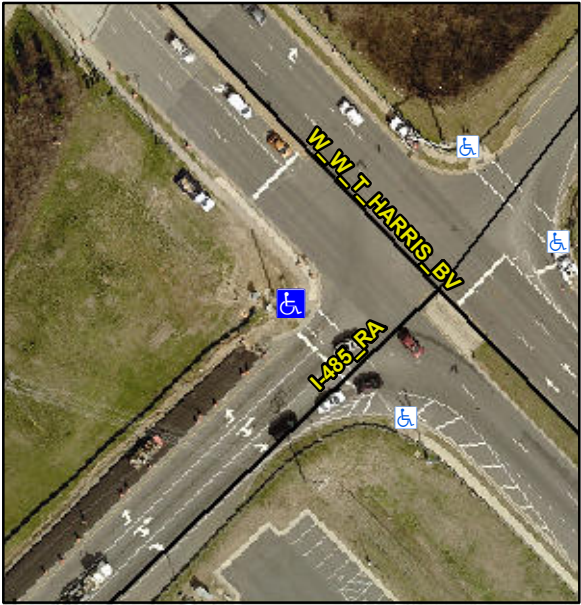
Possible Solutions:		<b>Compliance</b>	<b>Description</b>	<b>Data</b>
	<b>Remove &amp; Replace Entire Ramp.</b>		<b>Yes</b>	Ramp Length (in)	89.0
			<b>No</b>	Ramp Width (in)	46.0
			<b>N/A</b>	Flare Type LT	N/A
			<b>N/A</b>	Flare Slope LT (%)	N/A
			<b>N/A</b>	Flare Traversable LT?	N/A
			<b>N/A</b>	Landing Length (in)	N/A
			<b>N/A</b>	Landing Width (in)	N/A
			<b>N/A</b>	Landing Slope (%)	N/A
			<b>N/A</b>	Landing X Slope (%)	N/A
<p>Surveyor Notes:</p> <p><b>N/A</b></p> <p>PROW/ADA:</p> <p><b>Not Found, R304.5.1, R304.5.3</b></p>			<b>N/A</b>	Flare Type RT	N/A
			<b>N/A</b>	Flare Slope RT (%)	N/A
			<b>N/A</b>	Flare Traversable RT?	N/A
			<b>N/A</b>	DWS Provided?	N/A
			<b>N/A</b>	DWS Contrast?	N/A
			<b>N/A</b>	DWS Length (in)	N/A
			<b>N/A</b>	DWS Full Width?	N/A
			<b>N/A</b>	DWS Offset (in)	N/A
			<b>N/A</b>	Gutter Ponding?	N/A

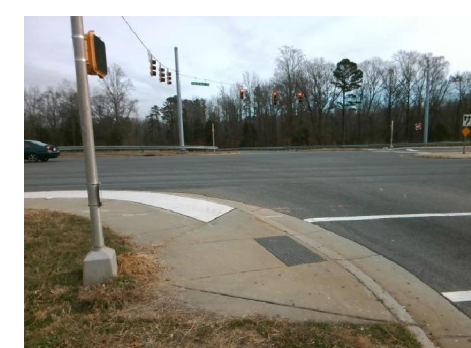
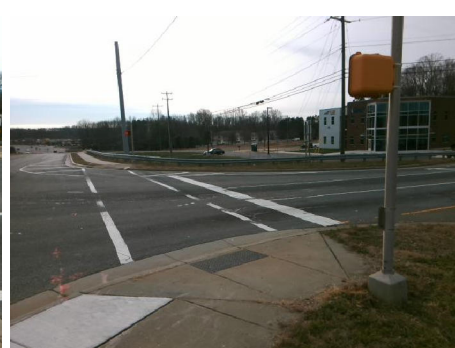
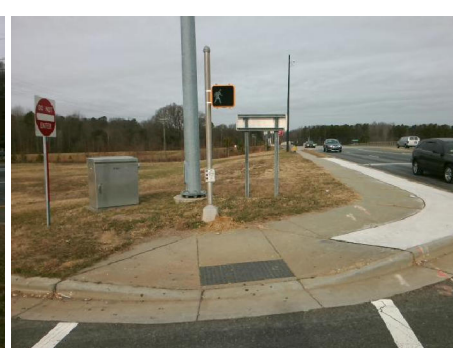
<b>N/A</b>	Gutter Lip Ht (in)	N/A
			<b>Yes</b>	Painted X Walk1?	N/A
				X Walk 1 Direction	To SE
			<b>N/A</b>	X Walk 1 Width (in)	120.0
				X Walk 1 Slope (%)	3.5
				X Walk 1 X Slope (%)	2.7
			<b>N/A</b>	Ramp inside XWalk1?	Yes
			<b>N/A</b>	Road Slope (%)	N/A
			<b>N/A</b>	Road X Slope (%)	N/A
			<b>N/A</b>	Any Obstructions?	N/A
				Obstruction Type	
Total Cost:					
					\$ 1850.00
			<b>N/A</b>	Clear Space?	N/A
			<b>N/A</b>	Clear Space to XWalk (in)	N/A
			<b>N/A</b>	Storm Grate/Utility Hazard?	N/A
				Storm Grate/Utility Type	
			<b>N/A</b>		N/A
			<b>Yes</b>	Surface Condition? (G/P)	Good
