Access Compliance Report

Public Rights-of-Way

(Curb Ramps)

Intersection ID: 10037035	Main Street: S_TRYON_ST	Cross Street: N/A	Location: S
ADA ID: 6A5B25CFF753	Ramp Type: Perp	Initial Pass/Fail: Fail	Overall Compliance: No
		Severity Score: 12.5

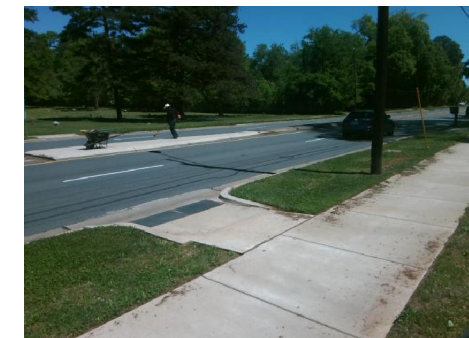
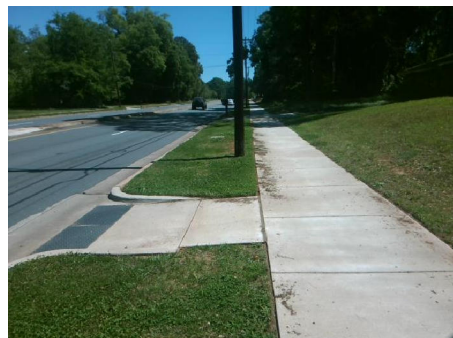
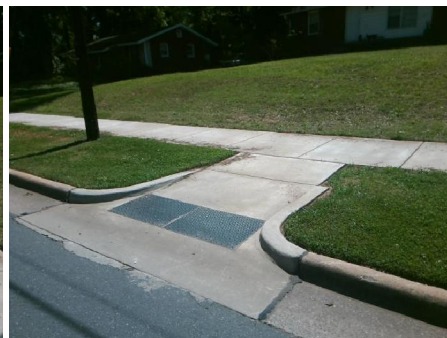
Compliance	Description	Data	Compliance	Description	Data
N/A	Ramp Length (in)	101.0	No	Ramp Slope (%)	8.7
Yes	Ramp Width (in)	72.0	Yes	Ramp XSlope (%)	1.5
N/A	Flare Type LT	N/A	N/A	Flare Type RT	N/A
N/A	Flare Slope LT (%)	N/A	N/A	Flare Slope RT (%)	N/A
N/A	Flare Traversable LT?	N/A	N/A	Flare Traversable RT?	N/A
N/A	Landing Length (in)	N/A	N/A	DWS Provided?	N/A
N/A	Landing Width (in)	N/A	N/A	DWS Contrast?	N/A
N/A	Landing Slope (%)	N/A	N/A	DWS Length (in)	N/A
N/A	Landing X Slope (%)	N/A	N/A	DWS Full Width?	N/A
N/A	Landing Curb? (Y/N)	N/A	N/A	DWS Offset (in)	N/A
N/A	Shared Landing?	N/A			
N/A	Gutter Ponding?	N/A	N/A	Gutter Slope (%)	N/A
N/A	Gutter Lip Ht (in)	N/A	N/A	Gutter X Slope (%)	N/A
N/A	Painted X Walk1?	No	N/A	Painted X Walk2?	N/A
	X Walk 1 Direction	To NW		X Walk 2 Direction	N/A
N/A	X Walk 1 Width (in)	N/A	N/A	X Walk 2 Width (in)	N/A
	X Walk 1 Slope (%)	1.4		X Walk 2 Slope (%)	N/A
	X Walk 1 X Slope (%)	2.7		X Walk 2 X Slope (%)	N/A

N/A	Ramp inside XWalk1?	N/A	N/A	Ramp inside XWalk2?	N/A
	Road Slope (%)	N/A	N/A	Clear Space?	N/A
	Road X Slope (%)	N/A	N/A	Clear Space to XWalk (in)	N/A
N/A	Any Obstructions?	N/A	N/A	Storm Grate/Utility Hazard?	N/A
	Obstruction Type			Storm Grate/Utility Type	
		N/A			N/A
			Yes	Surface Condition? (G/P)	Good

Remove & Replace Entire Ramp.

R304.2.2

\$ 1850.00
