Access Compliance Report

Public Rights-of-Way

(Curb Ramps)

Intersection ID: 27628	Main Street: BALLANTYNE COMMONS PY	Cross Street: ADAIR MANOR CT	Location: NW
ADA ID: 6A5BF807F9F3	Ramp Type: Perp	Initial Pass/Fail: Fail	Overall Compliance: No
Severity Score: 21.25			
Codes/Mitigation Info/Possible Solution		Field Measurements/Component Compliance

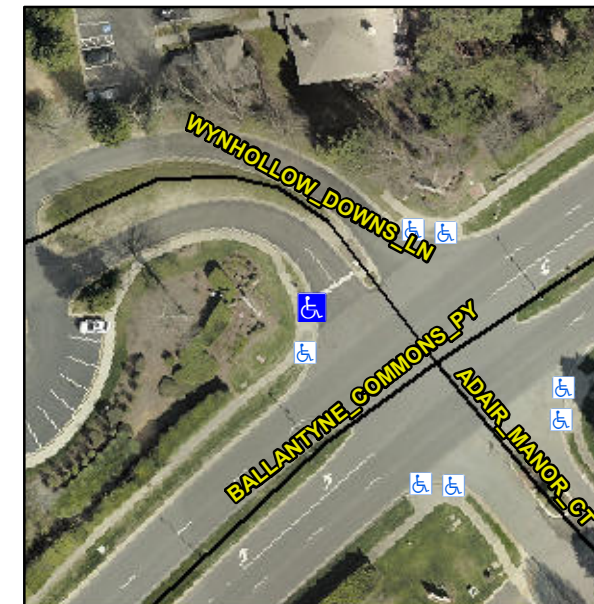
Not Found, R304.5.1, R304.5.3

Compliance	Description	Data	Compliance	Description	Data
N/A	Ramp Length (in)	108.0	Yes	Ramp Slope (%)	6.5
No	Ramp Width (in)	44.5	No	Ramp XSlope (%)	5.1
N/A	Flare Type LT	N/A	N/A	Flare Type RT	N/A
N/A	Flare Slope LT (%)	N/A	N/A	Flare Slope RT (%)	N/A
N/A	Flare Traversable LT?	N/A	N/A	Flare Traversable RT?	N/A
N/A	Landing Length (in)	N/A	N/A	DWS Provided?	N/A
N/A	Landing Width (in)	N/A	N/A	DWS Contrast?	N/A
N/A	Landing Slope (%)	N/A	N/A	DWS Length (in)	N/A
N/A	Landing X Slope (%)	N/A	N/A	DWS Full Width?	N/A
N/A	Landing Curb? (Y/N)	N/A	N/A	DWS Offset (in)	N/A
N/A	Shared Landing?	N/A			
N/A	Gutter Ponding?	N/A	N/A	Gutter Slope (%)	N/A
N/A	Gutter Lip Ht (in)	N/A	N/A	Gutter X Slope (%)	N/A
N/A	Painted X Walk1?	No	N/A	Painted X Walk2?	N/A
	X Walk 1 Direction	To NE		X Walk 2 Direction	N/A
N/A	X Walk 1 Width (in)	N/A	N/A	X Walk 2 Width (in)	N/A
	X Walk 1 Slope (%)	1.5		X Walk 2 Slope (%)	N/A
	X Walk 1 X Slope (%)	2.4		X Walk 2 X Slope (%)	N/A

N/A	Ramp inside XWalk1?	N/A	N/A	Ramp inside XWalk2?	N/A
	Road Slope (%)	N/A	N/A	Clear Space?	N/A
	Road X Slope (%)	N/A	N/A	Clear Space to XWalk (in)	N/A
N/A	Any Obstructions?	N/A	N/A	Storm Grate/Utility Hazard?	N/A
	Obstruction Type			Storm Grate/Utility Type	
		N/A			N/A
			Yes	Surface Condition? (G/P)	Good

Remove & Replace Entire Ramp.

Total Cost: \$ 1850.00
