# Access Compliance Report

## Public Rights-of-Way

### (Curb Ramps)

| Intersection ID: 24964 | Main Street: HUGH_FOREST_RD | Cross Street: TUCKERBUNN_DR | Location: SW |

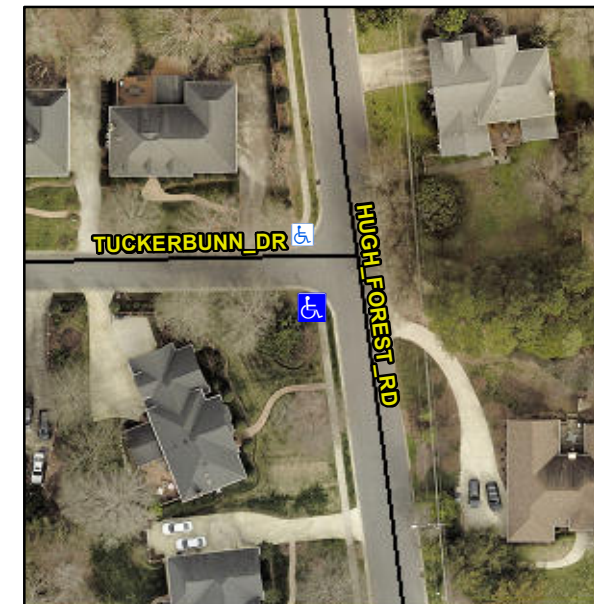
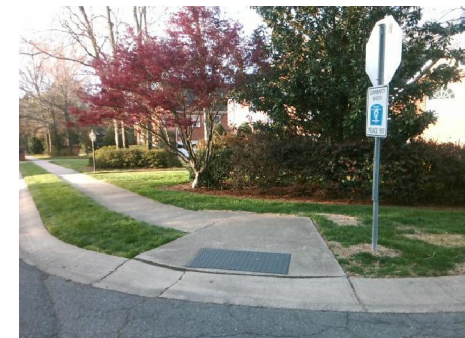
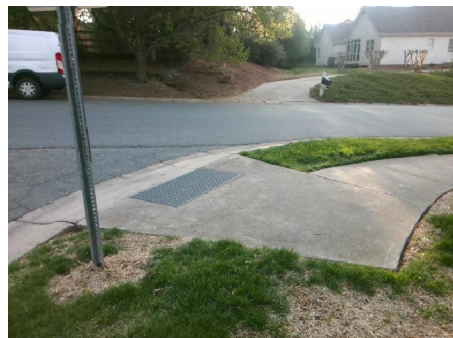
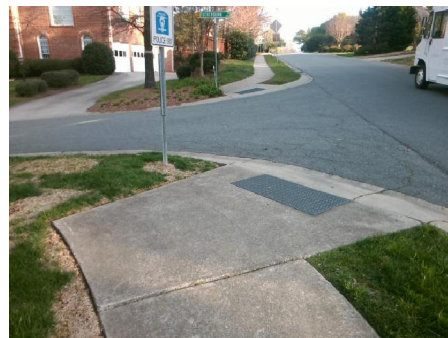
| ADA ID: 6A6D7BC0AFE7 | Ramp Type: BlendTrans1 | Initial Pass/Fail: Fail | Overall Compliance: No |
| | | Severity Score: 8.75 | |

**Not Found, R304.5.1**

| Compliance | Description | Data | Compliance | Description | Data |
|---|---|---|---|---|---|
| No | Ramp Width (in) | 47.5 | Yes | BlendTrans XSlope (%) | 1.5 |
| | | | No | Curb Slope (%) | 8.5 |

**Remove & Replace Curb Ramp With Two New Directional Ramps or Equivalent.**

Total Cost: \$ 3200.00
