Access Compliance Report

Public Rights-of-Way

(Curb Ramps)

| Intersection ID: 47108 | Main Street: FRANK_LITTLE_CT | Cross Street: ERNEST_RUSSELL_CT | Location: SE |

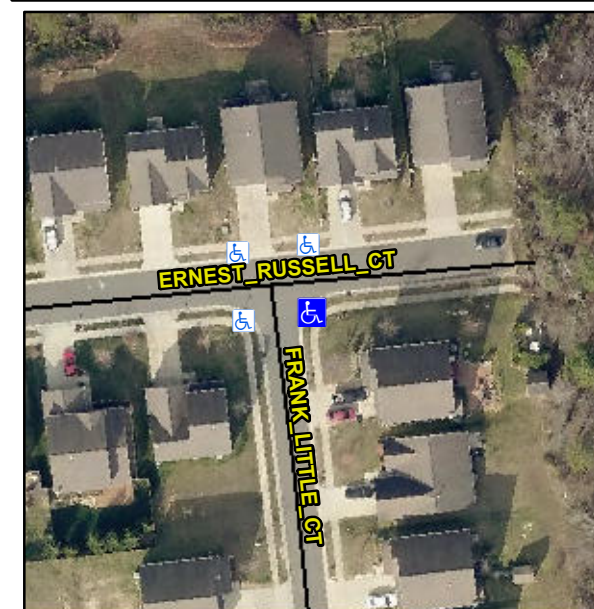
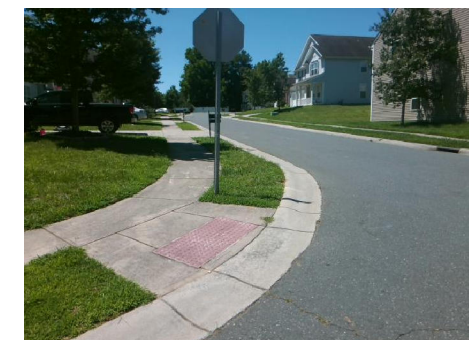
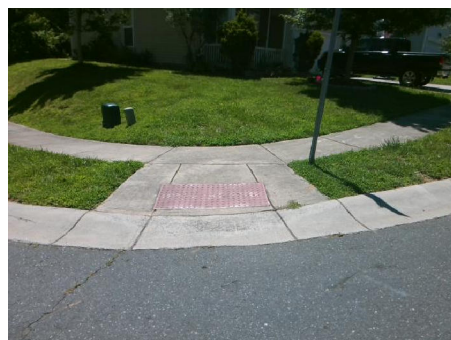
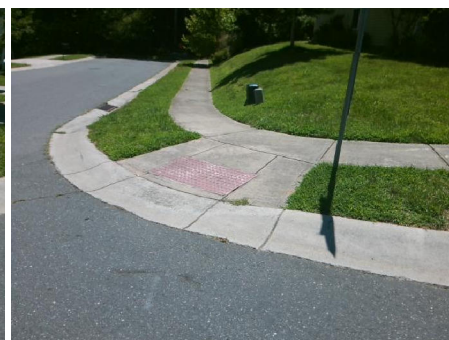
Not Found, R304.5.1, R304.2.2, R304.5.3

| Compliance | Description | Data | Compliance | Description | Data |
|---|---|---|---|---|---|
| N/A | Ramp Length (in) | 55.0 | No | Ramp Slope (%) | 11.0 |
| No | Ramp Width (in) | 36.0 | No | Ramp XSlope (%) | 8.3 |

Remove & Replace Curb Ramp With Two New Directional Ramps or Equivalent.
