# Access Compliance Report

## Public Rights-of-Way

### (Curb Ramps)

Intersection ID: 7132	Main Street: GRAHAM_MEADOW_DR	Cross Street: HOPE_VALLEY_LN	Location: W
ADA ID: 6A754C17E4D6	Ramp Type: BlendTrans1	Initial Pass/Fail: Fail	Overall Compliance: No
Severity Score: 8.75			
Codes/Mitigation Info/Possible Solution		Field Measurements/Component Compliance

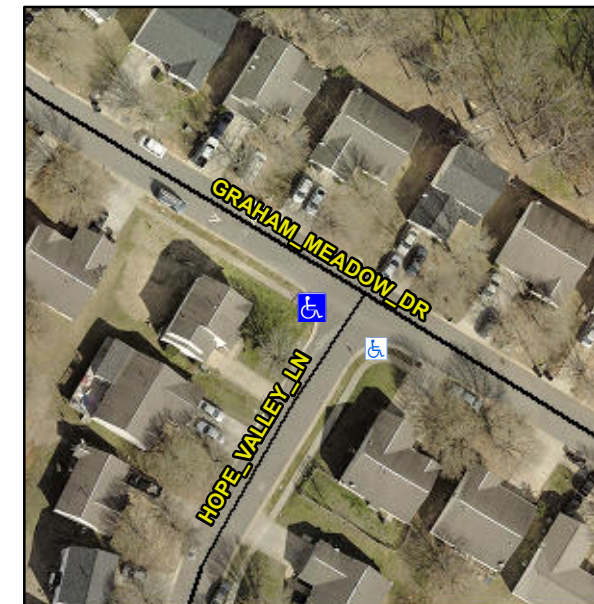
**DAMAGED LNDG**

**Not Found, R304.5.1**

**Remove & Replace Curb Ramp With Two New Directional Ramps or Equivalent.**

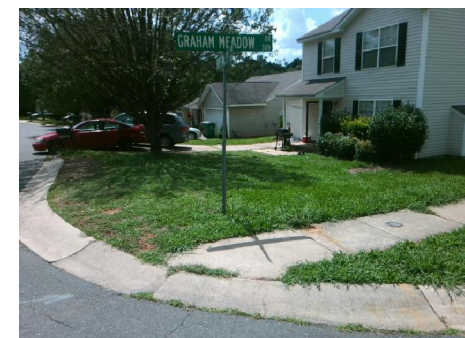
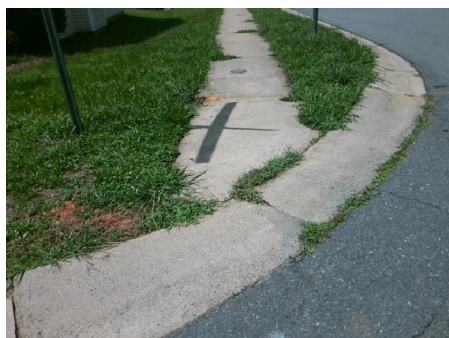
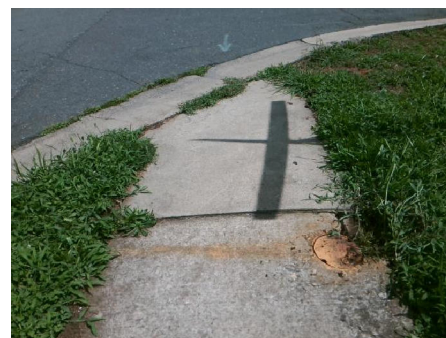
Compliance	Description	Data	Compliance	Description	Data
N/A	Ramp Length (in)	36.0	Yes	BlendTrans Slope (%)	1.6
No	Ramp Width (in)	47.5	Yes	BlendTrans XSlope (%)	1.3
N/A	Flare Type LT	N/A	N/A	Flare Type RT	N/A
N/A	Flare Slope LT (%)	N/A	N/A	Flare Slope RT (%)	N/A
N/A	Flare Traversable LT?	N/A	N/A	Flare Traversable RT?	N/A
N/A	Landing Length (in)	N/A	N/A	DWS Provided?	N/A
N/A	Landing Width (in)	N/A	N/A	DWS Contrast?	N/A
N/A	Landing Slope (%)	N/A	N/A	DWS Length (in)	N/A
N/A	Landing X Slope (%)	N/A	N/A	DWS Full Width?	N/A
N/A	Landing Curb? (Y/N)	N/A	N/A	DWS Offset (in)	N/A
N/A	Shared Landing?	N/A			
N/A	Gutter Ponding?	N/A	N/A	Gutter Slope (%)	N/A
N/A	Gutter Lip Ht (in)	N/A	N/A	Gutter X Slope (%)	N/A
N/A	Painted X Walk1?	No	N/A	Painted X Walk2?	N/A
	X Walk 1 Direction	To SE		X Walk 2 Direction	N/A
	X Walk 1 Width (in)	N/A		X Walk 2 Width (in)	N/A
	X Walk 1 Slope (%)	6.1		X Walk 2 Slope (%)	N/A
	X Walk 1 X Slope (%)	1.3		X Walk 2 X Slope (%)	N/A

N/A	Ramp inside XWalk1?	N/A	N/A	Ramp inside XWalk2?	N/A
	Road Slope (%)	1.3		Clear Space?	N/A
	Road X Slope (%)	6.1	N/A	Clear Space to XWalk (in)	N/A
N/A	Any Obstructions?	N/A	N/A	Storm Grate/Utility Hazard?	N/A
	Obstruction Type			Storm Grate/Utility Type	
		N/A			N/A
			Yes	Surface Condition? (G/P)	Good
			No	Curb Slope (%)	15.0
