Access Compliance Report

Public Rights-of-Way

(Curb Ramps)

Intersection ID: 5454	Main Street: PAVILION_BV	Cross Street: UNIVERSITY_CITY_BV	Location: NE
ADA ID: 6A8063A41BCF	Ramp Type: Perp	Initial Pass/Fail: Fail	Overall Compliance: No
Severity Score: 26.25			
Codes/Mitigation Info/Possible Solution		Field Measurements/Component Compliance

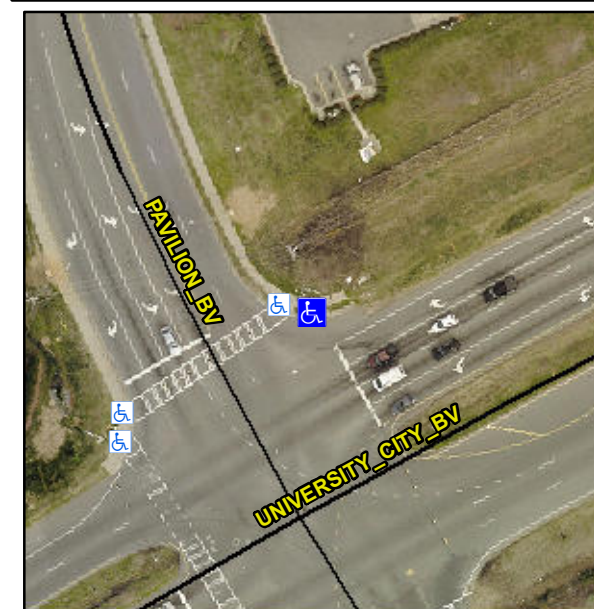
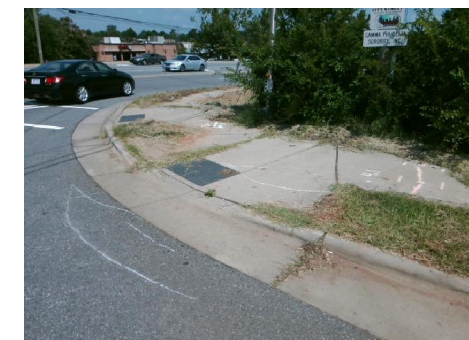
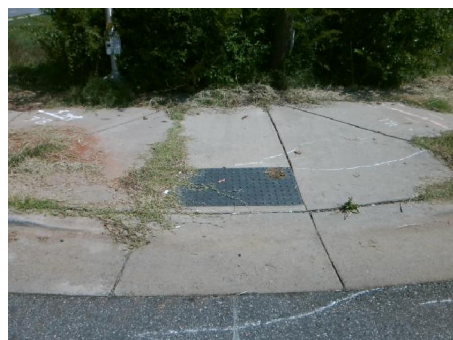
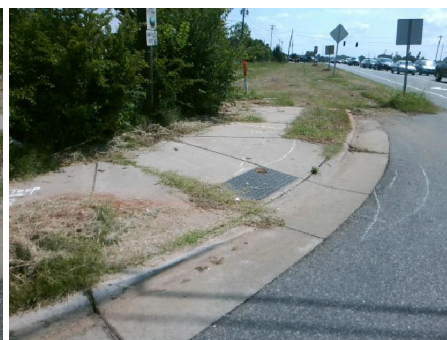
Not Found, R304.2.2, R304.5.3

Compliance	Description	Data	Compliance	Description	Data
N/A	Ramp Length (in)	96.0	No	Ramp Slope (%)	17.4
Yes	Ramp Width (in)	48.0	No	Ramp XSlope (%)	3.9
N/A	Flare Type LT	N/A	N/A	Flare Type RT	N/A
N/A	Flare Slope LT (%)	N/A	N/A	Flare Slope RT (%)	N/A
N/A	Flare Traversable LT?	N/A	N/A	Flare Traversable RT?	N/A
N/A	Landing Length (in)	N/A	N/A	DWS Provided?	N/A
N/A	Landing Width (in)	N/A	N/A	DWS Contrast?	N/A
N/A	Landing Slope (%)	N/A	N/A	DWS Length (in)	N/A
N/A	Landing X Slope (%)	N/A	N/A	DWS Full Width?	N/A
N/A	Landing Curb? (Y/N)	N/A	N/A	DWS Offset (in)	N/A
N/A	Shared Landing?	N/A			
N/A	Gutter Ponding?	N/A	N/A	Gutter Slope (%)	N/A
N/A	Gutter Lip Ht (in)	N/A	N/A	Gutter X Slope (%)	N/A
N/A	Painted X Walk1?	No	N/A	Painted X Walk2?	N/A
	X Walk 1 Direction	To S		X Walk 2 Direction	N/A
N/A	X Walk 1 Width (in)	N/A	N/A	X Walk 2 Width (in)	N/A
	X Walk 1 Slope (%)	2.3		X Walk 2 Slope (%)	N/A
	X Walk 1 X Slope (%)	2.7		X Walk 2 X Slope (%)	N/A

N/A	Ramp inside XWalk1?	N/A	N/A	Ramp inside XWalk2?	N/A
	Road Slope (%)	N/A	N/A	Clear Space?	N/A
	Road X Slope (%)	N/A	N/A	Clear Space to XWalk (in)	N/A
N/A	Any Obstructions?	N/A	N/A	Storm Grate/Utility Hazard?	N/A
	Obstruction Type			Storm Grate/Utility Type	
		N/A			N/A
		Yes		Surface Condition? (G/P)	Good

Possible Solutions:

Remove & Replace Entire Ramp.
