# Access Compliance Report

## Public Rights-of-Way

### (Curb Ramps)

Intersection ID: 14785	Main Street: ALBERTO_ST	Cross Street: CIRCLE_AV	Location: SW
ADA ID: 6A97258AEBD3	Ramp Type: Directional1	Initial Pass/Fail: Fail	Overall Compliance: No
		Severity Score: 1.25

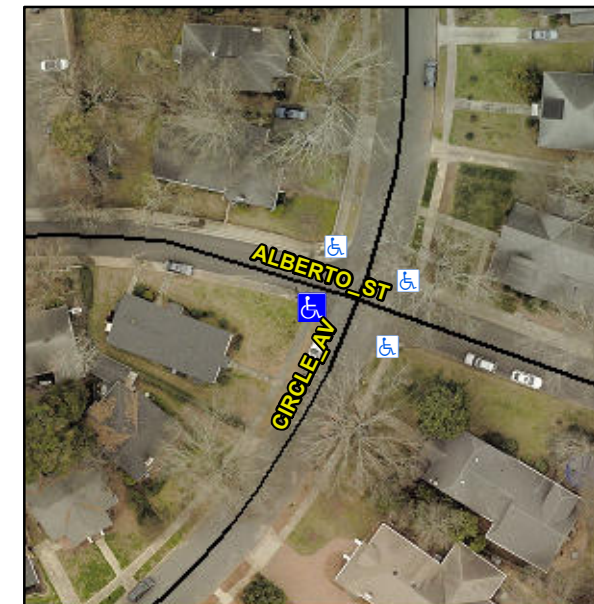
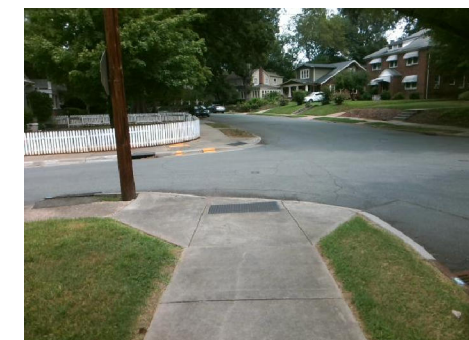
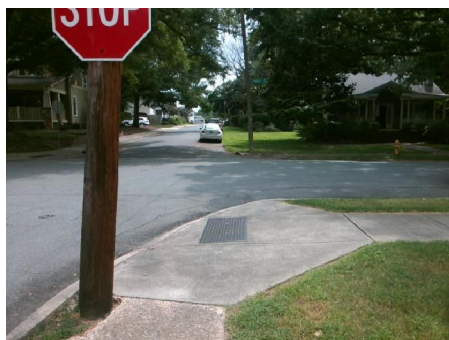
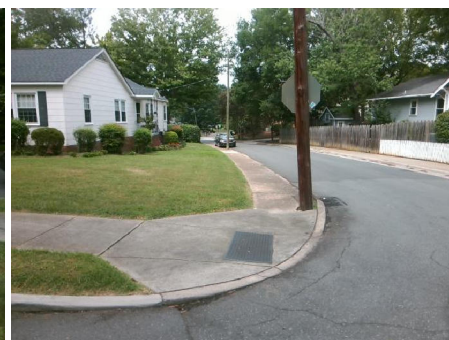
**R304.5.3**

Compliance	Description	Data	Compliance	Description	Data
N/A	Ramp Length (in)	94.0	N/A	Grade Break?	N/A
Yes	Ramp Width (in)	55.0	N/A	Grade Break Slope (%)	0.0
Yes	Ramp Slope (%)	6.0	N/A	Grade Break XSlope (%)	0.0
No	Ramp XSlope (%)	2.3			
N/A	Flare Type LT	N/A	N/A	Flare Type RT	N/A
N/A	Flare Slope LT (%)	N/A	N/A	Flare Slope RT (%)	0.0
N/A	Flare Traversable LT?	N/A	N/A	Flare Traversable RT?	N/A
N/A	Landing Length (in)	0.0	N/A	DWS Provided?	N/A
N/A	Landing Width (in)	0.0	N/A	DWS Contrast?	N/A
N/A	Landing Slope (%)	0.0	N/A	DWS Length (in)	N/A
N/A	Landing X Slope (%)	0.0	N/A	DWS Full Width?	N/A
N/A	Landing Curb? (Y/N)	N/A	N/A	DWS Offset LT (in)	N/A
N/A	Shared Landing?	N/A	N/A	DWS Offset RT (in)	N/A
N/A	Gutter Ponding?	0.0	N/A	Gutter Slope (%)	N/A
N/A	Gutter Lip Ht (in)	0.0	N/A	Gutter X Slope (%)	N/A
N/A	Painted X Walk1?	No		Road Slope (%)	1.1
	X Walk 1 Direction	To N		Road X Slope (%)	2.1
	X Walk 1 Width (in)	N/A		Clear Space?	N/A

X Walk 1 Slope (%)	1.1	N/A	Clear Space to XWalk (in)	N/A
	X Walk 1 X Slope (%)	2.1	N/A	Storm Grate/Utility Hazard?	N/A
N/A	Ramp inside XWalk1?	N/A		Storm Grate/Utility Type	
N/A	Any Obstructions?	N/A			N/A
	Obstruction Type		Yes	Surface Condition? (G/P)	Good
			N/A	Curb Slope (%)	8.3

**Remove & Replace Entire Ramp.**
