# Access Compliance Report

## Public Rights-of-Way

### (Curb Ramps)

Intersection ID: 49312	Main Street: MISTY_EVE_LN	Cross Street: BROOKE_NICOLE_PL	Location:	N
ADA ID: 6A98709109E5	Ramp Type: Perp	Initial Pass/Fail: Fail	Overall Compliance: No	Severity Score: 33.75

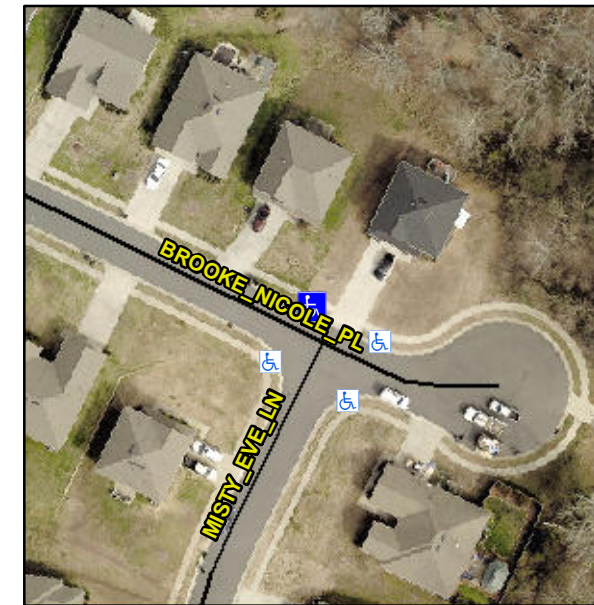
**Not Found, R304.5.1, R304.5.3**

Compliance	Description	Data	Compliance	Description	Data
N/A	Ramp Length (in)	47.0	Yes	Ramp Slope (%)	6.8
No	Ramp Width (in)	47.5	No	Ramp XSlope (%)	8.0
N/A	Flare Type LT	N/A	N/A	Flare Type RT	N/A
N/A	Flare Slope LT (%)	N/A	N/A	Flare Slope RT (%)	N/A
N/A	Flare Traversable LT?	N/A	N/A	Flare Traversable RT?	N/A
N/A	Landing Length (in)	N/A	N/A	DWS Provided?	N/A
N/A	Landing Width (in)	N/A	N/A	DWS Contrast?	N/A
N/A	Landing Slope (%)	N/A	N/A	DWS Length (in)	N/A
N/A	Landing X Slope (%)	N/A	N/A	DWS Full Width?	N/A
N/A	Landing Curb? (Y/N)	N/A	N/A	DWS Offset (in)	N/A
N/A	Shared Landing?	N/A			
N/A	Gutter Ponding?	N/A	N/A	Gutter Slope (%)	N/A
N/A	Gutter Lip Ht (in)	N/A	N/A	Gutter X Slope (%)	N/A
N/A	Painted X Walk1?	No	N/A	Painted X Walk2?	N/A
	X Walk 1 Direction	To W		X Walk 2 Direction	N/A
N/A	X Walk 1 Width (in)	N/A	N/A	X Walk 2 Width (in)	N/A
	X Walk 1 Slope (%)	3.4		X Walk 2 Slope (%)	N/A
	X Walk 1 X Slope (%)	9.3		X Walk 2 X Slope (%)	N/A

**Remove & Replace Entire Ramp.**
