# Access Compliance Report

### (Curb Ramps)

| Intersection ID: 14840 | Main Street: N_LAUREL_AV | Cross Street: VAIL_AV | Location: NE |
| ADA ID: 6AA2A4C6CEF1 | Ramp Type: ParaDiag | Initial Pass/Fail: Fail | Overall Compliance: No |

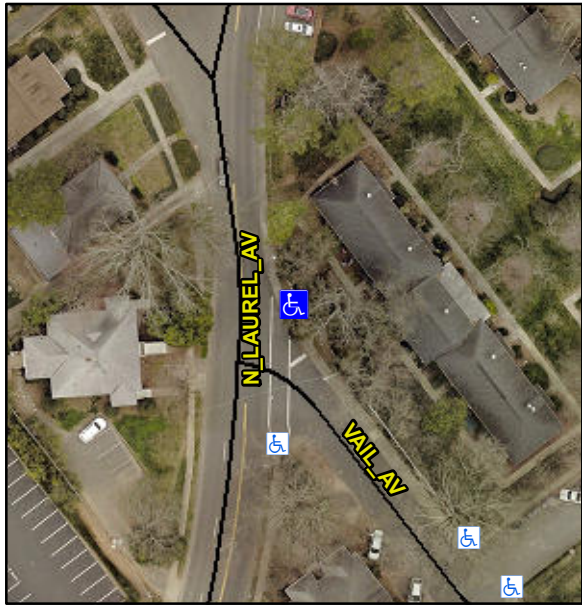
| Codes/Mitigation Info/Possible Solution | | | Field Measurements/Component Compliance | | | | | |
|---|---|---|---|---|---|---|---|---|
| | Remove & Replace Curb Ramp With Two New Directional Ramps or Equivalent. | | N/A | Ramp Length LT (in) | 68.0 | N/A | Ramp Length RT (in) | 72.0 |
| | | | Yes | Ramp Slope LT (%) | 2.9 | No | Ramp Slope RT (%) | 9.5 |
| | | | Yes | Ramp XSlope LT (%) | 0.0 | No | Ramp XSlope RT (%) | 2.3 |
| LT RP < 5% | | | N/A | Gutter Ponding? | N/A | N/A | Gutter Slope (%) | N/A |
| R304.3.2, R304.5.3 | | | N/A | Painted X Walk1? | No | N/A | Painted X Walk2? | Yes |
