Access Compliance Report

Public Rights-of-Way

(Curb Ramps)

Intersection ID: N/A	Main Street: NORTHLAKE CENTRE PY	Cross Street: PROSSER DR	Location: NW
ADA ID: 6AA36DFE86D8	Ramp Type: PerpDiag	Initial Pass/Fail: Pass	Overall Compliance: No
Codes/Mitigation Info/Possible Solution		Field Measurements/Component Compliance

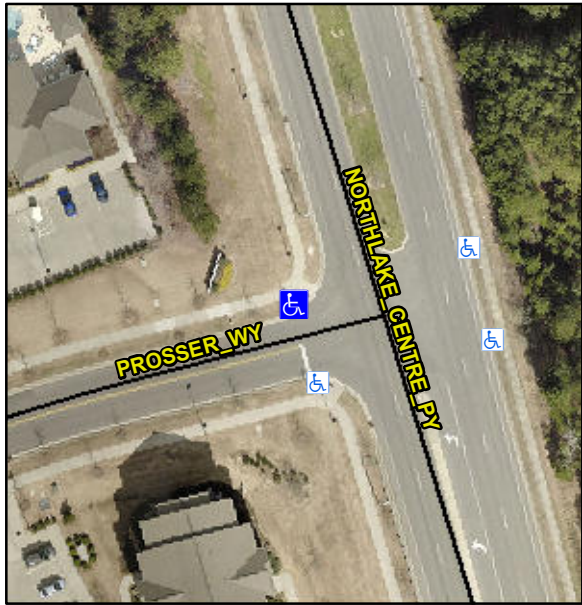
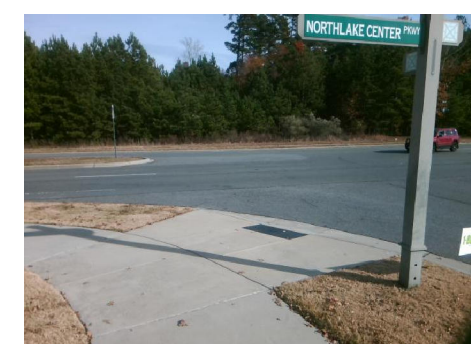
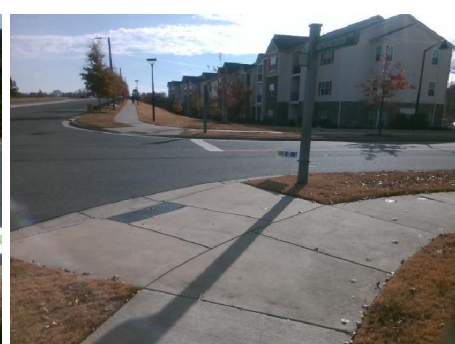
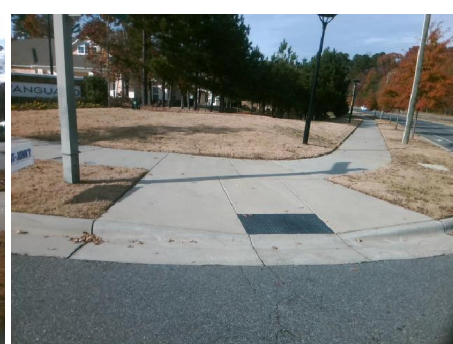
Possible Solutions:		Compliance		Description	Data	Compliance	Description	Data
	Remove & Replace Curb Ramp With Two New Directional Ramps or Equivalent.		N/A	Ramp Length (in)	96.0	Yes	Ramp Slope (%)	7.7	
			Yes	Ramp Width (in)	48.0	No	Ramp XSlope (%)	4.7	
			N/A	Flare Type LT	Sloped	N/A	Flare Type RT	N/A	
			N/A	Flare Slope LT (%)	8.8	N/A	Flare Slope RT (%)	3.2	
			N/A	Flare Traversable LT?	No	N/A	Flare Traversable RT?	No	
			Yes	Landing Length (in)	72.5	Yes	DWS Provided?	Yes	
			Yes	Landing Width (in)	48.0	Yes	DWS Contrast?	Yes	
			No	Landing Slope (%)	2.2	Yes	DWS Length (in)	24.5	
			No	Landing X Slope (%)	6.2	Yes	DWS Full Width?	Yes	
Surveyor Notes:		N/A	N/A	Landing Curb? (Y/N)	No	Yes	DWS Offset (in)	2.0	
		N/A	Shared Landing?	No					
PROW/ADA:		Yes	Gutter Ponding?	No	Yes	Gutter Slope (%)	3.5		
		Yes	Gutter Lip Ht (in)	0.0	Yes	Gutter X Slope (%)	1.4		
		N/A	Painted X Walk1?	No	N/A	Painted X Walk2?	No

X Walk 1 Direction	To S		X Walk 2 Direction	To E		
		N/A	X Walk 1 Width (in)	N/A	N/A	X Walk 2 Width (in)	N/A		
			X Walk 1 Slope (%)	4.1		X Walk 2 Slope (%)	0.5		
			X Walk 1 X Slope (%)	0.6		X Walk 2 X Slope (%)	3.2		
		N/A	Ramp inside XWalk1?	N/A	N/A	Ramp inside XWalk2?	N/A		
			Road Slope (%)	1.4	N/A	Clear Space?	Yes		
			Road X Slope (%)	2.0	N/A	Clear Space to XWalk (in)	N/A		
		Yes	Any Obstructions?	No	Yes	Storm Grate/Utility Hazard?	No		
			Obstruction Type			Storm Grate/Utility Type			
					N/A		N/A		
					Yes	Surface Condition? (G/P)	Good		
Total Cost:		\$	3200.00
