Access Compliance Report

Public Rights-of-Way

(Curb Ramps)

Intersection ID: 13184	Main Street: S_MINT_ST	Cross Street: S_MINT_ST	Location: SW
ADA ID: 6AA56C0A3BE2	Ramp Type: Perp	Initial Pass/Fail: Fail	Overall Compliance: No
		Severity Score: 37.5

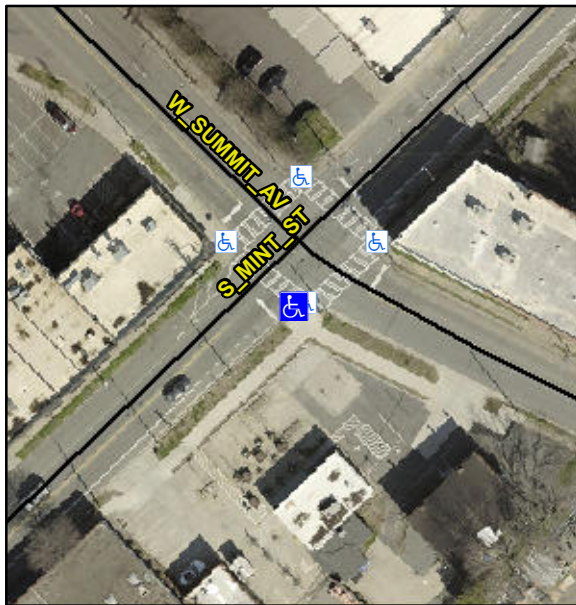
Not Found, R304.2.2, R304.5.3

Compliance	Description	Data	Compliance	Description	Data
N/A	Ramp Length (in)	96.0	No	Ramp Slope (%)	10.1
Yes	Ramp Width (in)	102.0	No	Ramp XSlope (%)	8.1
N/A	Flare Type LT	N/A	N/A	Flare Type RT	N/A
N/A	Flare Slope LT (%)	N/A	N/A	Flare Slope RT (%)	N/A
N/A	Flare Traversable LT?	N/A	N/A	Flare Traversable RT?	N/A
N/A	Landing Length (in)	N/A	N/A	DWS Provided?	N/A
N/A	Landing Width (in)	N/A	N/A	DWS Contrast?	N/A
N/A	Landing Slope (%)	N/A	N/A	DWS Length (in)	N/A
N/A	Landing X Slope (%)	N/A	N/A	DWS Full Width?	N/A
N/A	Landing Curb? (Y/N)	N/A	N/A	DWS Offset (in)	N/A
N/A	Shared Landing?	N/A			
N/A	Gutter Ponding?	N/A	N/A	Gutter Slope (%)	N/A
N/A	Gutter Lip Ht (in)	N/A	N/A	Gutter X Slope (%)	N/A
N/A	Painted X Walk1?	Yes	N/A	Painted X Walk2?	N/A
	X Walk 1 Direction	To NW		X Walk 2 Direction	N/A
N/A	X Walk 1 Width (in)	105.0	N/A	X Walk 2 Width (in)	N/A
	X Walk 1 Slope (%)	3.8		X Walk 2 Slope (%)	N/A
	X Walk 1 X Slope (%)	1.5		X Walk 2 X Slope (%)	N/A

N/A	Ramp inside XWalk1?	No	N/A	Ramp inside XWalk2?	N/A
	Road Slope (%)	N/A	N/A	Clear Space?	N/A
	Road X Slope (%)	N/A	N/A	Clear Space to XWalk (in)	N/A
N/A	Any Obstructions?	N/A	N/A	Storm Grate/Utility Hazard?	N/A
	Obstruction Type			Storm Grate/Utility Type	
		N/A			N/A
			Yes	Surface Condition? (G/P)	Good

**Remove & Replace Entire Ramp.
Restripe Crosswalk.**
