# Access Compliance Report

## Public Rights-of-Way

### (Curb Ramps)

| Intersection ID: 52289 | Main Street: DIXIE_RIVER_RD | Cross Street: GANNON_DR | Location: S |

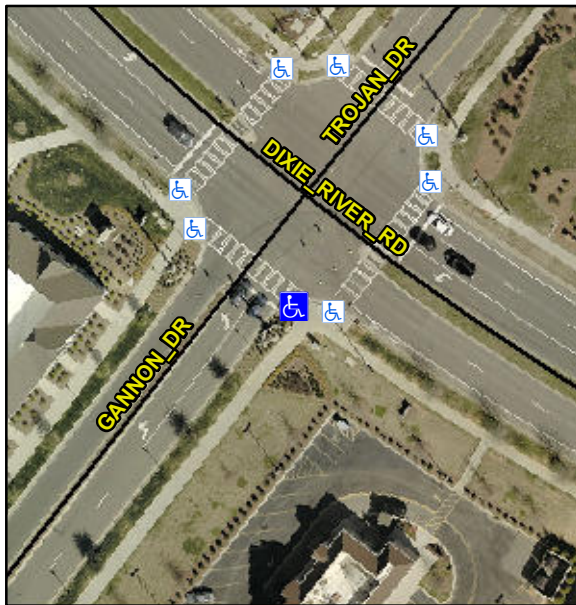
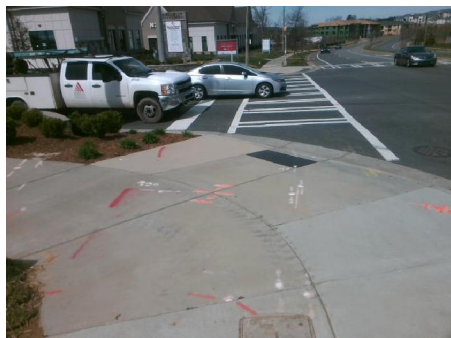
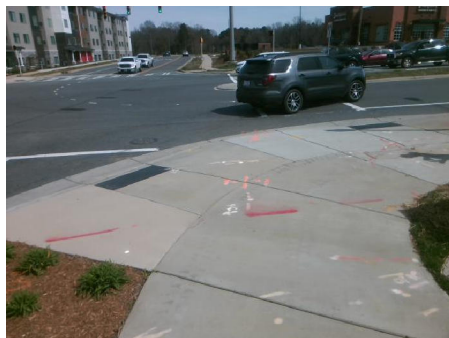
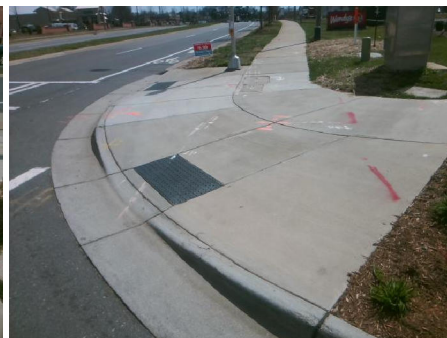
**Not Found, R304.5.3, R304.2.1,  
R304.2.2-Perp, R304.3.2-Para**

| Compliance | Description | Data | Compliance | Description | Data |
|---|---|---|---|---|---|
| Yes | Ramp Width (in) | 48.0 | No | Ramp XSlope (%) | 3.1 |
| No | Landing Width (in) | 47.5 | Yes | DWS Contrast? | Yes |
| No | Landing Slope (%) | 3.0 | Yes | DWS Length (in) | 24.0 |
| Yes | Gutter Lip Ht (in) | 0.0 | No | Gutter X Slope (%) | 3.2 |

Possible Solutions:

**Remove & Replace Entire Ramp.  
Remove & Replace Gutter.**
