Access Compliance Report

Public Rights-of-Way

(Curb Ramps)

Intersection ID: 50586	Main Street: LONGSTRAW_RD	Cross Street: DOWNY_BIRCH_RD	Location: SE
ADA ID: 6ABD5F61EC05	Ramp Type: Perp	Initial Pass/Fail: Fail	Overall Compliance: No
Severity Score: 33.75			
Codes/Mitigation Info/Possible Solution		Field Measurements/Component Compliance

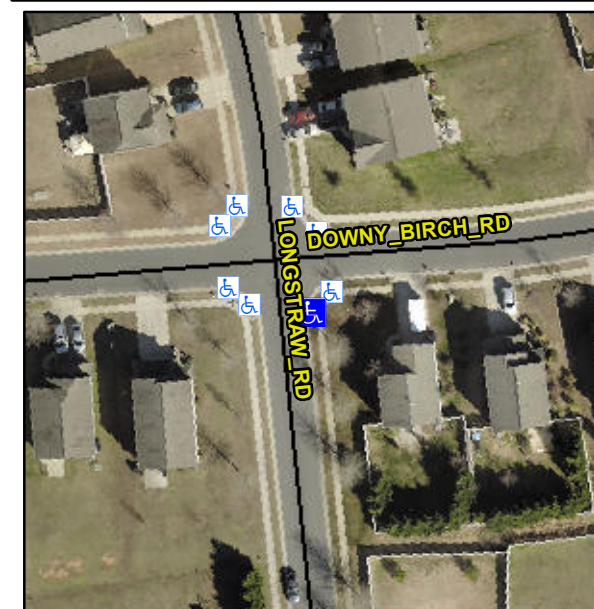
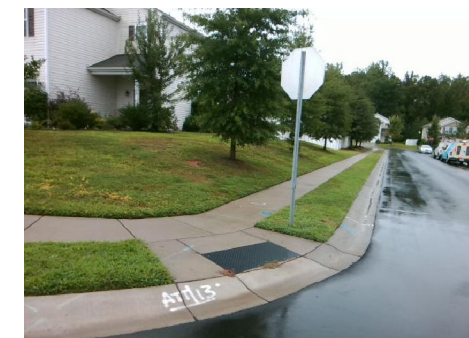
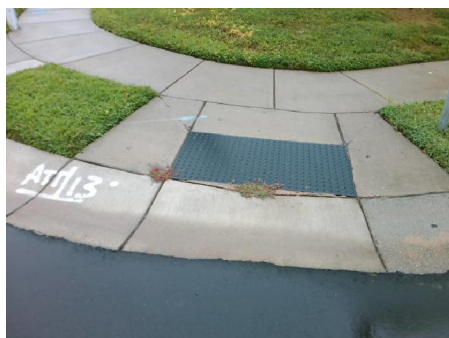
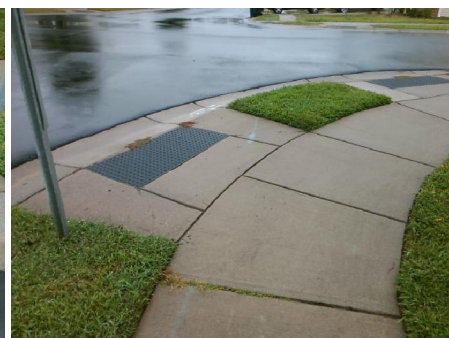
Not Found, R304.5.1, R304.5.3

Compliance	Description	Data	Compliance	Description	Data
N/A	Ramp Length (in)	47.5	Yes	Ramp Slope (%)	5.9
No	Ramp Width (in)	45.5	No	Ramp XSlope (%)	7.3
N/A	Flare Type LT	N/A	N/A	Flare Type RT	N/A
N/A	Flare Slope LT (%)	N/A	N/A	Flare Slope RT (%)	N/A
N/A	Flare Traversable LT?	N/A	N/A	Flare Traversable RT?	N/A
N/A	Landing Length (in)	N/A	N/A	DWS Provided?	N/A
N/A	Landing Width (in)	N/A	N/A	DWS Contrast?	N/A
N/A	Landing Slope (%)	N/A	N/A	DWS Length (in)	N/A
N/A	Landing X Slope (%)	N/A	N/A	DWS Full Width?	N/A
N/A	Landing Curb? (Y/N)	N/A	N/A	DWS Offset (in)	N/A
N/A	Shared Landing?	N/A			
N/A	Gutter Ponding?	N/A	N/A	Gutter Slope (%)	N/A
N/A	Gutter Lip Ht (in)	N/A	N/A	Gutter X Slope (%)	N/A
N/A	Painted X Walk1?	No	N/A	Painted X Walk2?	N/A
	X Walk 1 Direction	To W		X Walk 2 Direction	N/A
N/A	X Walk 1 Width (in)	N/A	N/A	X Walk 2 Width (in)	N/A
	X Walk 1 Slope (%)	0.5		X Walk 2 Slope (%)	N/A
	X Walk 1 X Slope (%)	2.6		X Walk 2 X Slope (%)	N/A

N/A	Ramp inside XWalk1?	N/A	N/A	Ramp inside XWalk2?	N/A
	Road Slope (%)	N/A	N/A	Clear Space?	N/A
	Road X Slope (%)	N/A	N/A	Clear Space to XWalk (in)	N/A
N/A	Any Obstructions?	N/A	N/A	Storm Grate/Utility Hazard?	N/A
	Obstruction Type			Storm Grate/Utility Type	
		N/A			N/A
			Yes	Surface Condition? (G/P)	Good

Possible Solutions:

Remove & Replace Entire Ramp.
