Intersection ID: 49557	Main Street: STEEL_YARD_CT	Cross Street: WARREN_BURGESS_LN	Location:	NW
ADA ID: 6ABDB8298B97	Ramp Type: Perp	Initial Pass/Fail: Fail	Overall Compliance: No	Severity Score: 33.75

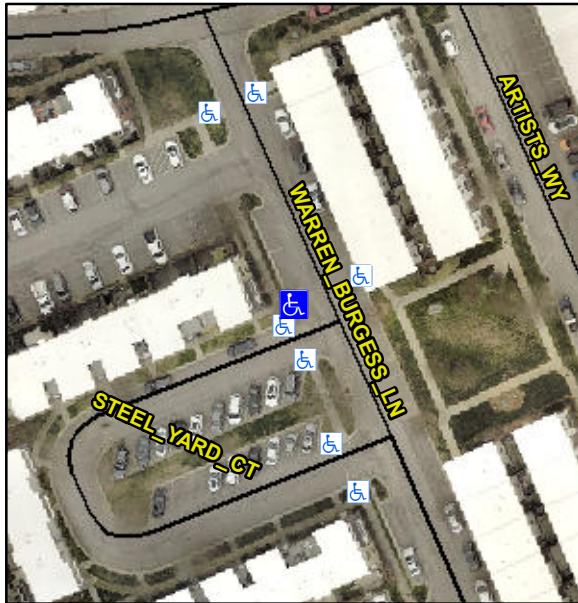
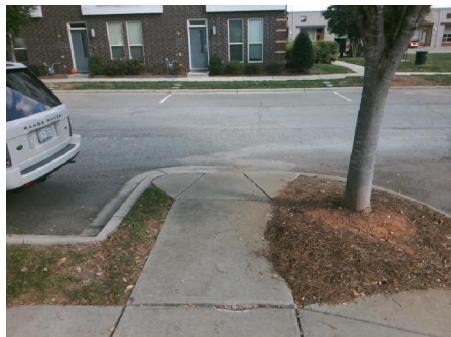
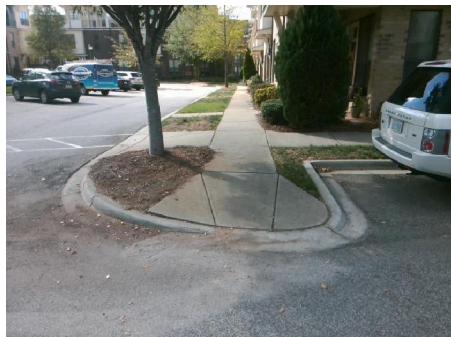
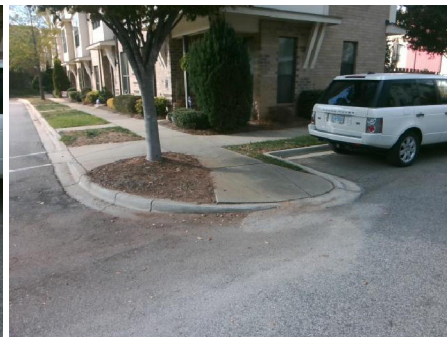
Not Found, R304.5.1, R304.2.2

Compliance	Description	Data	Compliance	Description	Data
N/A	Ramp Length (in)	60.0	No	Ramp Slope (%)	15.7
No	Ramp Width (in)	47.0	Yes	Ramp XSlope (%)	1.8
N/A	Flare Type LT	N/A	N/A	Flare Type RT	N/A
N/A	Flare Slope LT (%)	N/A	N/A	Flare Slope RT (%)	N/A
N/A	Flare Traversable LT?	N/A	N/A	Flare Traversable RT?	N/A
N/A	Landing Length (in)	N/A	N/A	DWS Provided?	N/A
N/A	Landing Width (in)	N/A	N/A	DWS Contrast?	N/A
N/A	Landing Slope (%)	N/A	N/A	DWS Length (in)	N/A
N/A	Landing X Slope (%)	N/A	N/A	DWS Full Width?	N/A
N/A	Landing Curb? (Y/N)	N/A	N/A	DWS Offset (in)	N/A
N/A	Shared Landing?	N/A			
N/A	Gutter Ponding?	N/A	N/A	Gutter Slope (%)	N/A
N/A	Gutter Lip Ht (in)	N/A	N/A	Gutter X Slope (%)	N/A
N/A	Painted X Walk1?	No	N/A	Painted X Walk2?	N/A
	X Walk 1 Direction	To E		X Walk 2 Direction	N/A
N/A	X Walk 1 Width (in)	N/A	N/A	X Walk 2 Width (in)	N/A
	X Walk 1 Slope (%)	2.2		X Walk 2 Slope (%)	N/A
	X Walk 1 X Slope (%)	0.0		X Walk 2 X Slope (%)	N/A

N/A	Ramp inside XWalk1?	N/A	N/A	Ramp inside XWalk2?	N/A
	Road Slope (%)	N/A	N/A	Clear Space?	N/A
	Road X Slope (%)	N/A	N/A	Clear Space to XWalk (in)	N/A
N/A	Any Obstructions?	N/A	N/A	Storm Grate/Utility Hazard?	N/A
	Obstruction Type			Storm Grate/Utility Type	
		N/A			N/A
			Yes	Surface Condition? (G/P)	Good

Remove & Replace Entire Ramp.

Total Cost: \$ 1850.00
