Access Compliance Report

Public Rights-of-Way

(Curb Ramps)

Intersection ID: 28662	Main Street: MEADOWMONT_DR	Cross Street: MEADOWMONT_VIEW_DR	Location: SW
ADA ID: 6AC37A8AEF62	Ramp Type: PerpDiag	Initial Pass/Fail: Pass	Overall Compliance: No
Severity Score: 10			
Codes/Mitigation Info/Possible Solution		Field Measurements/Component Compliance

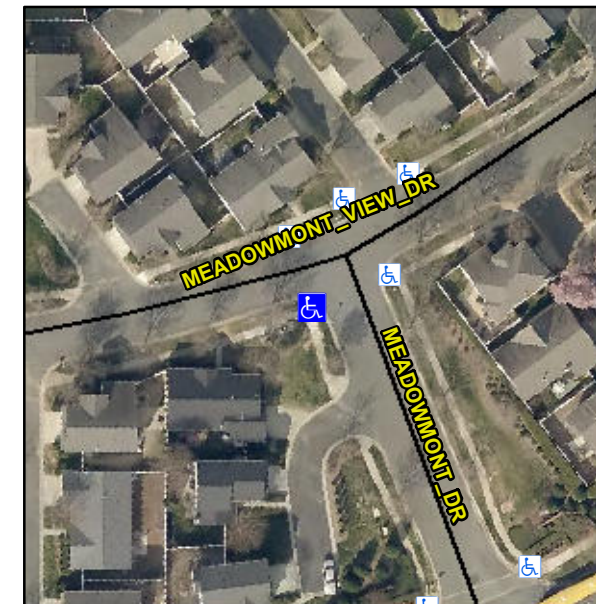
PROW/ADA:

Not Found, R305

Compliance	Description	Data	Compliance	Description	Data
N/A	Ramp Length (in)	52.0	Yes	Ramp Slope (%)	5.4
Yes	Ramp Width (in)	60.0	Yes	Ramp XSlope (%)	0.7
N/A	Flare Type LT	Sloped	N/A	Flare Type RT	N/A
N/A	Flare Slope LT (%)	3.3	Yes	Flare Slope RT (%)	5.6
N/A	Flare Traversable LT?	Yes	N/A	Flare Traversable RT?	Yes
Yes	Landing Length (in)	58.0	No	DWS Provided?	No
Yes	Landing Width (in)	54.0	N/A	DWS Contrast?	No
Yes	Landing Slope (%)	0.2	N/A	DWS Length (in)	N/A
Yes	Landing X Slope (%)	1.5	N/A	DWS Full Width?	No
N/A	Landing Curb? (Y/N)	No	N/A	DWS Offset (in)	N/A
N/A	Shared Landing?	No			
Yes	Gutter Ponding?	No	Yes	Gutter Slope (%)	1.8
Yes	Gutter Lip Ht (in)	0.0	Yes	Gutter X Slope (%)	1.0
N/A	Painted X Walk1?	No	N/A	Painted X Walk2?	No
	X Walk 1 Direction	To E		X Walk 2 Direction	To N
N/A	X Walk 1 Width (in)	N/A	N/A	X Walk 2 Width (in)	N/A
	X Walk 1 Slope (%)	2.6		X Walk 2 Slope (%)	3.8
	X Walk 1 X Slope (%)	2.2		X Walk 2 X Slope (%)	2.4

N/A	Ramp inside XWalk1?	N/A	N/A	Ramp inside XWalk2?	N/A
	Road Slope (%)	0.6	N/A	Clear Space?	Yes
	Road X Slope (%)	2.9	N/A	Clear Space to XWalk (in)	N/A
Yes	Any Obstructions?	No	Yes	Storm Grate/Utility Hazard?	No
	Obstruction Type			Storm Grate/Utility Type	
		N/A			N/A
			Yes	Surface Condition? (G/P)	Good

Possible Solutions:

Remove & Replace Curb Ramp With Two New Directional Ramps or Equivalent.
