Access Compliance Report

Public Rights-of-Way

(Curb Ramps)

Intersection ID: 13409	Main Street: WINNIFRED_ST	Cross Street: WINONA_ST	Location: S
ADA ID: 6AC5219EF9F7	Ramp Type: PerpDiag	Initial Pass/Fail: Fail	Overall Compliance: No
		Severity Score: 37.5

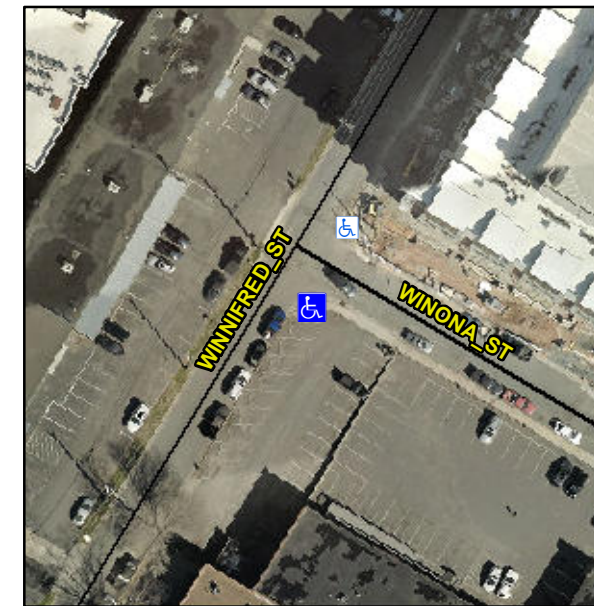
Compliance	Description	Data	Compliance	Description	Data
N/A	Ramp Length (in)	47.0	No	Ramp Slope (%)	15.8
Yes	Ramp Width (in)	48.0	No	Ramp XSlope (%)	5.2
N/A	Flare Type LT	N/A	N/A	Flare Type RT	N/A
N/A	Flare Slope LT (%)	N/A	N/A	Flare Slope RT (%)	N/A
N/A	Flare Traversable LT?	N/A	N/A	Flare Traversable RT?	N/A
N/A	Landing Length (in)	N/A	N/A	DWS Provided?	N/A
N/A	Landing Width (in)	N/A	N/A	DWS Contrast?	N/A
N/A	Landing Slope (%)	N/A	N/A	DWS Length (in)	N/A
N/A	Landing X Slope (%)	N/A	N/A	DWS Full Width?	N/A
N/A	Landing Curb? (Y/N)	N/A	N/A	DWS Offset (in)	N/A
N/A	Shared Landing?	N/A			
N/A	Gutter Ponding?	Yes	N/A	Gutter Slope (%)	N/A
N/A	Gutter Lip Ht (in)	N/A	N/A	Gutter X Slope (%)	N/A
N/A	Painted X Walk1?	No	N/A	Painted X Walk2?	No
	X Walk 1 Direction	To NE		X Walk 2 Direction	To NW
N/A	X Walk 1 Width (in)	N/A	N/A	X Walk 2 Width (in)	N/A
	X Walk 1 Slope (%)	1.5		X Walk 2 Slope (%)	0.4
	X Walk 1 X Slope (%)	2.4		X Walk 2 X Slope (%)	2.3

N/A	Ramp inside XWalk1?	N/A	N/A	Ramp inside XWalk2?	N/A
	Road Slope (%)	1.6	N/A	Clear Space?	N/A
	Road X Slope (%)	1.5	N/A	Clear Space to XWalk (in)	N/A
N/A	Any Obstructions?	N/A	N/A	Storm Grate/Utility Hazard?	N/A
	Obstruction Type			Storm Grate/Utility Type	
		N/A			N/A
		Yes		Surface Condition? (G/P)	Good

Remove & Replace Curb Ramp With Two New Directional Ramps or Equivalent.

R304.2.2, R304.5.3
