Access Compliance Report

Public Rights-of-Way

(Curb Ramps)

Intersection ID: N/A	Main Street: SOUTHGROVE_ST	Cross Street: WAVERLY_CENTER_DR	Location: NW
ADA ID: 6AC7882DE94B	Ramp Type: Perp	Initial Pass/Fail: Fail	Overall Compliance: No
Severity Score: 8.75			
Codes/Mitigation Info/Possible Solution		Field Measurements/Component Compliance

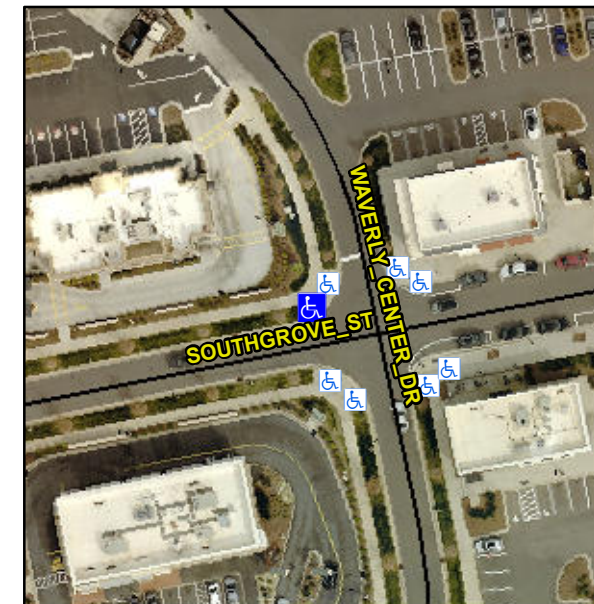
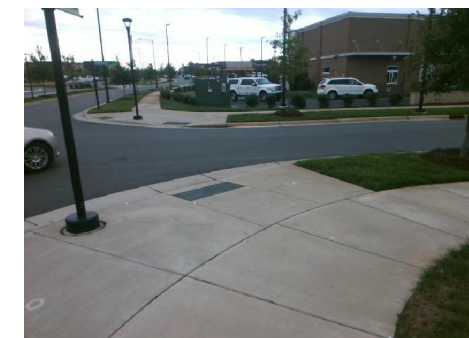
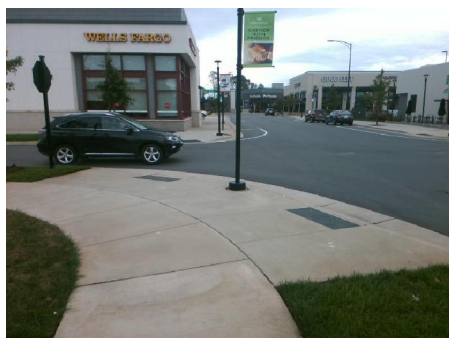
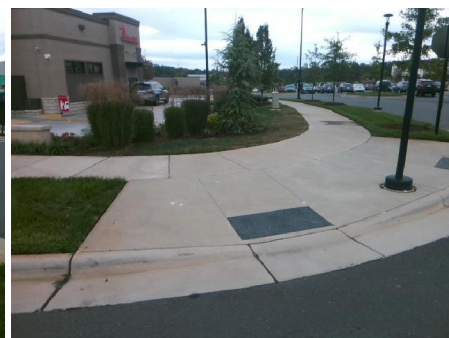
Compliance	Description	Data	Compliance	Description	Data
N/A	Ramp Length (in)	95.0	Yes	Ramp Slope (%)	6.7
No	Ramp Width (in)	45.5	Yes	Ramp XSlope (%)	1.9
N/A	Flare Type LT	N/A	N/A	Flare Type RT	N/A
N/A	Flare Slope LT (%)	N/A	N/A	Flare Slope RT (%)	N/A
N/A	Flare Traversable LT?	N/A	N/A	Flare Traversable RT?	N/A
N/A	Landing Length (in)	N/A	N/A	DWS Provided?	N/A
N/A	Landing Width (in)	N/A	N/A	DWS Contrast?	N/A
N/A	Landing Slope (%)	N/A	N/A	DWS Length (in)	N/A
N/A	Landing X Slope (%)	N/A	N/A	DWS Full Width?	N/A
N/A	Landing Curb? (Y/N)	N/A	N/A	DWS Offset (in)	N/A
N/A	Shared Landing?	N/A			
N/A	Gutter Ponding?	N/A	N/A	Gutter Slope (%)	N/A
N/A	Gutter Lip Ht (in)	N/A	N/A	Gutter X Slope (%)	N/A
N/A	Painted X Walk1?	No	N/A	Painted X Walk2?	N/A
	X Walk 1 Direction	To S		X Walk 2 Direction	N/A
N/A	X Walk 1 Width (in)	N/A	N/A	X Walk 2 Width (in)	N/A
	X Walk 1 Slope (%)	0.1		X Walk 2 Slope (%)	N/A
	X Walk 1 X Slope (%)	0.7		X Walk 2 X Slope (%)	N/A

N/A	Ramp inside XWalk1?	N/A	N/A	Ramp inside XWalk2?	N/A
	Road Slope (%)	N/A	N/A	Clear Space?	N/A
	Road X Slope (%)	N/A	N/A	Clear Space to XWalk (in)	N/A
N/A	Any Obstructions?	N/A	N/A	Storm Grate/Utility Hazard?	N/A
	Obstruction Type			Storm Grate/Utility Type	
		N/A			N/A
			Yes	Surface Condition? (G/P)	Good

Possible Solutions:

Remove & Replace Entire Ramp.

R304.5.1
