Access Compliance Report Public Rights-of-Way (Curb Ramps)

Intersection ID: N/A Main Street: S CALDWELL ST Cross Street: JOHN_BELK_RA Location: SE ADA ID: 6AD4BA6DC356 Ramp Type: PerpDiag Initial Pass/Fail: Fail **Overall Compliance: No Severity Score:** 12.5

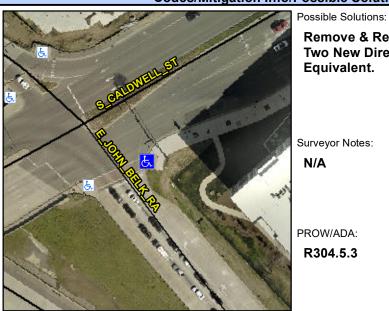
Field Measurements/Component Compliance						
	Compliance Description		Data	Compliance Description		Data
	N/A	Ramp Length (in)	120.0	Yes	Ramp Slope (%)	6.5
	Yes	Ramp Width (in)	48.0	No	Ramp XSlope (%)	5.6
	N/A	Flare Type LT	N/A	N/A	Flare Type RT	N/A
	N/A	Flare Slope LT (%)	N/A	N/A	Flare Slope RT (%)	N/A
	N/A	Flare Traversable LT?	No	N/A	Flare Traversable RT?	No
	N/A	Landing Length (in)	N/A	N/A	DWS Provided?	N/A
	N/A	Landing Width (in)	N/A	N/A	DWS Contrast?	N/A
	N/A	Landing Slope (%)	N/A	N/A	DWS Length (in)	N/A
	N/A	Landing X Slope (%)	N/A	N/A	DWS Full Width?	N/A
	N/A	Landing Curb? (Y/N)	N/A	N/A	DWS Offset (in)	N/A
	N/A	Shared Landing?	N/A			
	N/A	Gutter Ponding?	N/A	N/A	Gutter Slope (%)	N/A
	N/A	Gutter Lip Ht (in)	N/A	N/A	Gutter X Slope (%)	N/A
	N/A	Painted X Walk1?	No	N/A	Painted X Walk2?	Yes
		X Walk 1 Direction	To N		X Walk 2 Direction	To W
	N/A	X Walk 1 Width (in)	N/A	N/A	X Walk 2 Width (in)	124.5
		X Walk 1 Slope (%)	5.6		X Walk 2 Slope (%)	3.0

X Walk 1 X Slope (%)	0.9		X Walk 2 X Slope (%)	3.2
	N/A	Ramp inside XWalk1?	N/A	N/A	Ramp inside XWalk2?	Yes
		Road Slope (%)	2.4	N/A	Clear Space?	N/A
		Road X Slope (%)	3.3	N/A	Clear Space to XWalk (in)	N/A
	N/A	Any Obstructions?	N/A	N/A	Storm Grate/Utility Hazard?	N/A
		Obstruction Type			Storm Grate/Utility Type	
			N/A			N/A
				Yes	Surface Condition? (G/P)	Good
_

S CALDWELL ST Street 1 Name Stop Condition-Street 2 Signal **E JOHN BELK RA** Street 2 Name Stop Condition-Street 1 Signal Remove & Replace Curb Ramp With **Two New Directional Ramps or** Equivalent.

R304.5.3
