Access Compliance Report

Public Rights-of-Way

(Curb Ramps)

Intersection ID: 4705	Main Street: HARRIS_HOUSTON_RD	Cross Street: KEMPSFORD_DR	Location: W
ADA ID: 6AD7E6131264	Ramp Type: Perp	Initial Pass/Fail: Fail	Overall Compliance: No
Severity Score: 26.25			
Codes/Mitigation Info/Possible Solution		Field Measurements/Component Compliance

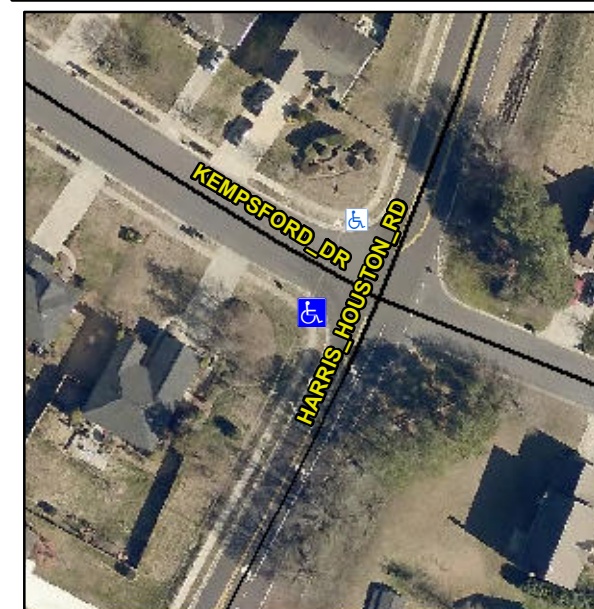
R304.2.2, R304.5.3

Compliance	Description	Data	Compliance	Description	Data
N/A	Ramp Length (in)	46.0	No	Ramp Slope (%)	12.5
Yes	Ramp Width (in)	49.0	No	Ramp XSlope (%)	5.0
N/A	Flare Type LT	N/A	N/A	Flare Type RT	N/A
N/A	Flare Slope LT (%)	N/A	N/A	Flare Slope RT (%)	N/A
N/A	Flare Traversable LT?	N/A	N/A	Flare Traversable RT?	N/A
N/A	Landing Length (in)	N/A	N/A	DWS Provided?	N/A
N/A	Landing Width (in)	N/A	N/A	DWS Contrast?	N/A
N/A	Landing Slope (%)	N/A	N/A	DWS Length (in)	N/A
N/A	Landing X Slope (%)	N/A	N/A	DWS Full Width?	N/A
N/A	Landing Curb? (Y/N)	N/A	N/A	DWS Offset (in)	N/A
N/A	Shared Landing?	N/A			
N/A	Gutter Ponding?	N/A	N/A	Gutter Slope (%)	N/A
N/A	Gutter Lip Ht (in)	N/A	N/A	Gutter X Slope (%)	N/A
N/A	Painted X Walk1?	No	N/A	Painted X Walk2?	N/A
	X Walk 1 Direction	To NE		X Walk 2 Direction	N/A
N/A	X Walk 1 Width (in)	N/A	N/A	X Walk 2 Width (in)	N/A
	X Walk 1 Slope (%)	1.4		X Walk 2 Slope (%)	N/A
	X Walk 1 X Slope (%)	5.2		X Walk 2 X Slope (%)	N/A

N/A	Ramp inside XWalk1?	N/A	N/A	Ramp inside XWalk2?	N/A
	Road Slope (%)	N/A	N/A	Clear Space?	N/A
	Road X Slope (%)	N/A	N/A	Clear Space to XWalk (in)	N/A
N/A	Any Obstructions?	N/A	N/A	Storm Grate/Utility Hazard?	N/A
	Obstruction Type			Storm Grate/Utility Type	
		N/A			N/A
			Yes	Surface Condition? (G/P)	Good

Possible Solutions:

Remove & Replace Entire Ramp.

Total Cost: \$ 1850.00
