# Access Compliance Report

## Public Rights-of-Way

### (Curb Ramps)

Intersection ID: 28382	Main Street: NEWTON_LN	Cross Street: TONAWANDA_DR	Location:	E
ADA ID: 6ADCD64EADAC	Ramp Type: Perp	Initial Pass/Fail: Fail	Overall Compliance: No	Severity Score: 30
Codes/Mitigation Info/Possible Solution		Field Measurements/Component Compliance

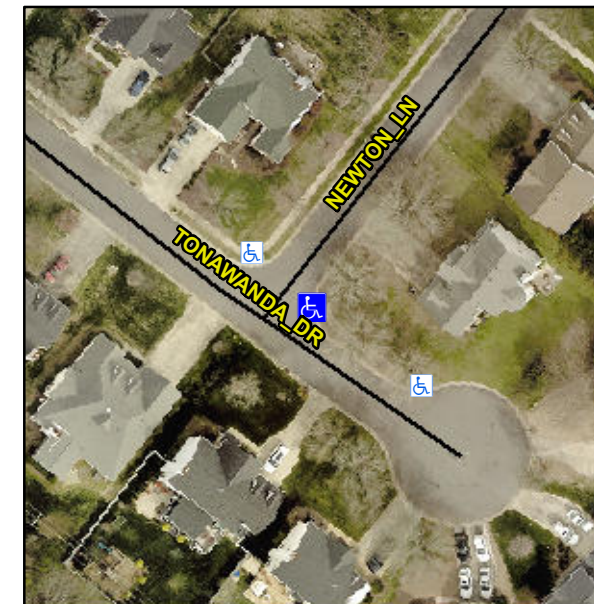
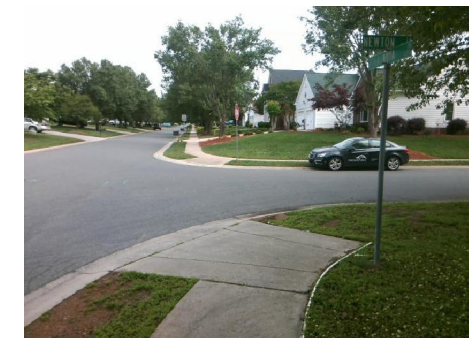
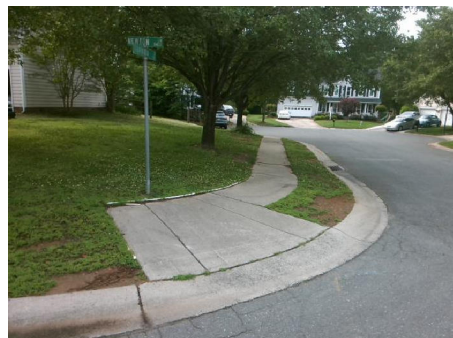
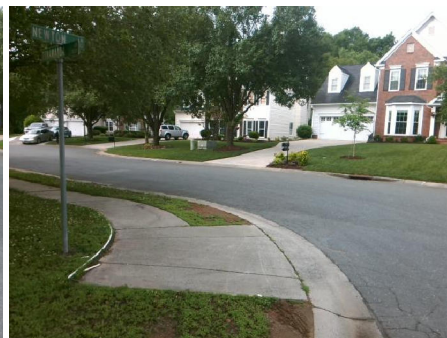
Compliance	Description	Data	Compliance	Description	Data
N/A	Ramp Length (in)	95.0	No	Ramp Slope (%)	9.7
No	Ramp Width (in)	33.0	Yes	Ramp XSlope (%)	1.4
N/A	Flare Type LT	N/A	N/A	Flare Type RT	N/A
N/A	Flare Slope LT (%)	N/A	N/A	Flare Slope RT (%)	N/A
N/A	Flare Traversable LT?	N/A	N/A	Flare Traversable RT?	N/A
N/A	Landing Length (in)	N/A	N/A	DWS Provided?	N/A
N/A	Landing Width (in)	N/A	N/A	DWS Contrast?	N/A
N/A	Landing Slope (%)	N/A	N/A	DWS Length (in)	N/A
N/A	Landing X Slope (%)	N/A	N/A	DWS Full Width?	N/A
N/A	Landing Curb? (Y/N)	N/A	N/A	DWS Offset (in)	N/A
N/A	Shared Landing?	N/A			
N/A	Gutter Ponding?	N/A	N/A	Gutter Slope (%)	N/A
N/A	Gutter Lip Ht (in)	N/A	N/A	Gutter X Slope (%)	N/A
N/A	Painted X Walk1?	No	N/A	Painted X Walk2?	N/A
	X Walk 1 Direction	To NW		X Walk 2 Direction	N/A
N/A	X Walk 1 Width (in)	N/A	N/A	X Walk 2 Width (in)	N/A
	X Walk 1 Slope (%)	2.9		X Walk 2 Slope (%)	N/A
	X Walk 1 X Slope (%)	1.9		X Walk 2 X Slope (%)	N/A

N/A	Ramp inside XWalk1?	N/A	N/A	Ramp inside XWalk2?	N/A
	Road Slope (%)	0.4	N/A	Clear Space?	N/A
	Road X Slope (%)	2.1	N/A	Clear Space to XWalk (in)	N/A
N/A	Any Obstructions?	N/A	N/A	Storm Grate/Utility Hazard?	N/A
	Obstruction Type			Storm Grate/Utility Type	
		N/A			N/A
			Yes	Surface Condition? (G/P)	Good

Possible Solutions:

**Remove & Replace Entire Ramp.**

**R304.5.1, R304.2.2**

Total Cost: \$ 1850.00
