## **Access Compliance Report Public Rights-of-Way** (Curb Ramps)

Intersection ID: 15127 Main Street: EXECUTIVE\_CR Cross Street: REGAL\_OAKS\_DR Location: SW **Overall Compliance: No** ADA ID: 6ADD723B33B6 Ramp Type: Perp Initial Pass/Fail: Fail Severity Score: 21.25

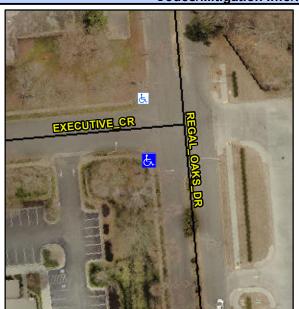
| Possible Solutions: | | | | | | |
|---|--|--|--|--|--|--|
| Not Found, R304.5.1, R304.2.2 | | | | | | |

| Field Measurements/Component Compliance | | | | | | | |
|---|---|---|---|---|---|---|--|
| N/A | Ramp Length (in) | 102.0 | No | Ramp | Slope (%) | 8.4 | |
| No | Ramp Width (in) | 40.0 | Yes | Ramp | XSlope (%) | 1.6 | |

| Possible Solutions: | | | | | | |
|---|--|--|--|--|--|--|
| Remove & Replace Entire Ramp. | | | | | | |

1850.00
