Access Compliance Report

Public Rights-of-Way

(Curb Ramps)

Intersection ID: 31563	Main Street: DORIS_RAY_CT	Cross Street: MCCORD_ST	Location: SW
ADA ID: 6AE031CC697D	Ramp Type: Perp	Initial Pass/Fail: Fail	Overall Compliance: No
Severity Score: 22.5			
Codes/Mitigation Info/Possible Solution		Field Measurements/Component Compliance

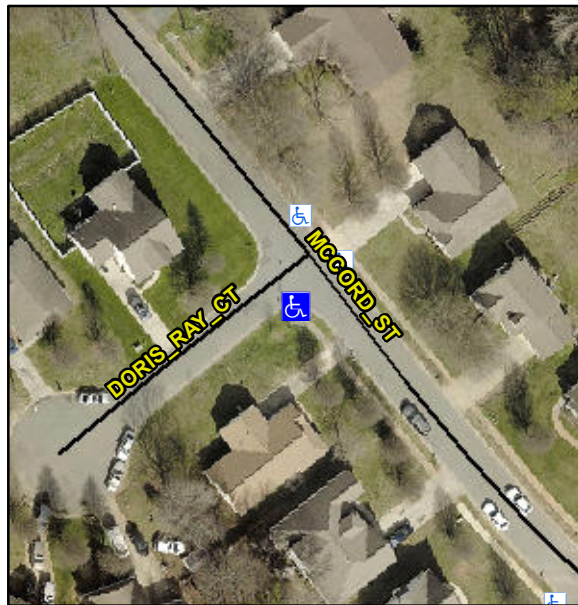
Compliance	Description	Data	Compliance	Description	Data
N/A	Ramp Length (in)	49.0	No	Ramp Slope (%)	9.9
No	Ramp Width (in)	43.0	No	Ramp XSlope (%)	4.1
N/A	Flare Type LT	N/A	N/A	Flare Type RT	N/A
N/A	Flare Slope LT (%)	N/A	N/A	Flare Slope RT (%)	N/A
N/A	Flare Traversable LT?	N/A	N/A	Flare Traversable RT?	N/A
N/A	Landing Length (in)	N/A	N/A	DWS Provided?	N/A
N/A	Landing Width (in)	N/A	N/A	DWS Contrast?	N/A
N/A	Landing Slope (%)	N/A	N/A	DWS Length (in)	N/A
N/A	Landing X Slope (%)	N/A	N/A	DWS Full Width?	N/A
N/A	Landing Curb? (Y/N)	N/A	N/A	DWS Offset (in)	N/A
N/A	Shared Landing?	N/A			
N/A	Gutter Ponding?	N/A	N/A	Gutter Slope (%)	N/A
N/A	Gutter Lip Ht (in)	N/A	N/A	Gutter X Slope (%)	N/A
N/A	Painted X Walk1?	No	N/A	Painted X Walk2?	N/A
	X Walk 1 Direction	To E		X Walk 2 Direction	N/A
N/A	X Walk 1 Width (in)	N/A	N/A	X Walk 2 Width (in)	N/A
	X Walk 1 Slope (%)	2.4		X Walk 2 Slope (%)	N/A
	X Walk 1 X Slope (%)	0.9		X Walk 2 X Slope (%)	N/A

Possible Solutions:

Remove & Replace Entire Ramp.

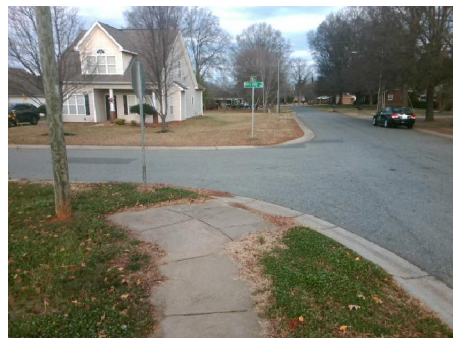
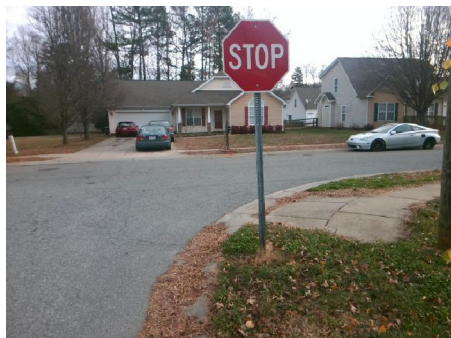
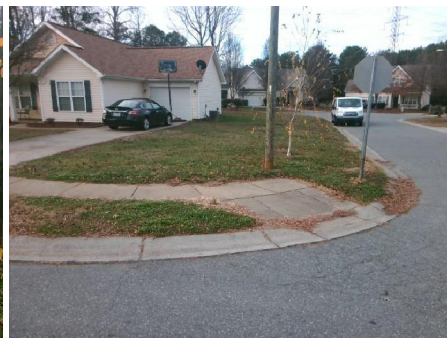
N/A	Ramp inside XWalk1?	N/A	N/A	Ramp inside XWalk2?	N/A
	Road Slope (%)	N/A	N/A	Clear Space?	N/A
	Road X Slope (%)	N/A	N/A	Clear Space to XWalk (in)	N/A
N/A	Any Obstructions?	N/A	N/A	Storm Grate/Utility Hazard?	N/A
	Obstruction Type			Storm Grate/Utility Type	
		N/A			N/A
			Yes	Surface Condition? (G/P)	Good
