# Access Compliance Report

## Public Rights-of-Way

### (Curb Ramps)

Intersection ID: 53894	Main Street: INVERNESS_BAY_RD	Cross Street: PERTH_MOOR_RD	Location: NW
ADA ID: 6AE4A2F413E7	Ramp Type: BlendTrans1	Initial Pass/Fail: Fail	Overall Compliance: No
		Severity Score: 8.75

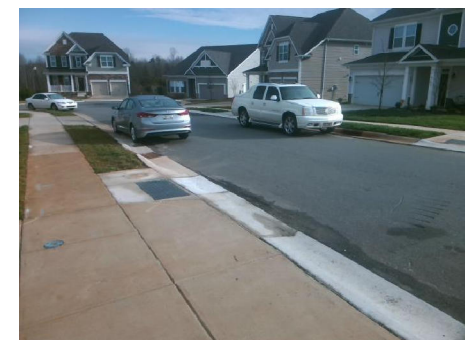
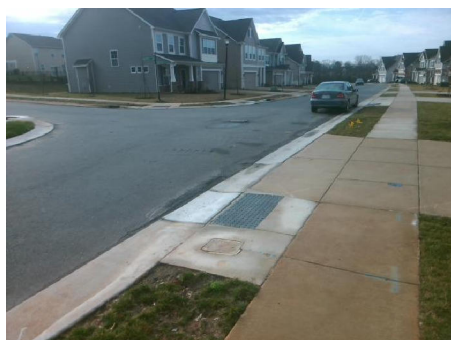
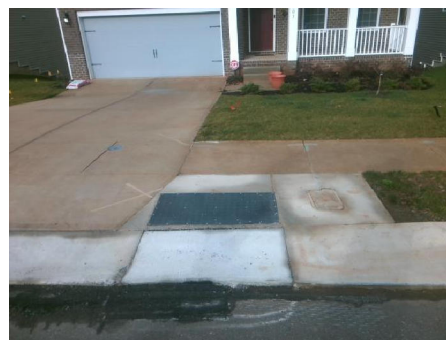
**Not Found, R304.5.1**

Compliance	Description	Data	Compliance	Description	Data
N/A	Ramp Length (in)	48.0	Yes	BlendTrans Slope (%)	2.2
No	Ramp Width (in)	43.0	Yes	BlendTrans XSlope (%)	0.3
N/A	Flare Type LT	N/A	N/A	Flare Type RT	N/A
N/A	Flare Slope LT (%)	N/A	N/A	Flare Slope RT (%)	N/A
N/A	Flare Traversable LT?	N/A	N/A	Flare Traversable RT?	N/A
N/A	Landing Length (in)	N/A	N/A	DWS Provided?	N/A
N/A	Landing Width (in)	N/A	N/A	DWS Contrast?	N/A
N/A	Landing Slope (%)	N/A	N/A	DWS Length (in)	N/A
N/A	Landing X Slope (%)	N/A	N/A	DWS Full Width?	N/A
N/A	Landing Curb? (Y/N)	N/A	N/A	DWS Offset (in)	N/A
N/A	Shared Landing?	N/A			
N/A	Gutter Ponding?	N/A	N/A	Gutter Slope (%)	N/A
N/A	Gutter Lip Ht (in)	2.0	N/A	Gutter X Slope (%)	N/A
N/A	Painted X Walk1?	No	N/A	Painted X Walk2?	N/A
	X Walk 1 Direction	To E		X Walk 2 Direction	N/A
	X Walk 1 Width (in)	N/A		X Walk 2 Width (in)	N/A
	X Walk 1 Slope (%)	2.8		X Walk 2 Slope (%)	N/A
	X Walk 1 X Slope (%)	0.7		X Walk 2 X Slope (%)	N/A

N/A	Ramp inside XWalk1?	N/A	N/A	Ramp inside XWalk2?	N/A
	Road Slope (%)	0.7		Clear Space?	N/A
	Road X Slope (%)	2.8	N/A	Clear Space to XWalk (in)	N/A
N/A	Any Obstructions?	N/A	N/A	Storm Grate/Utility Hazard?	N/A
	Obstruction Type			Storm Grate/Utility Type	
		N/A			N/A
			Yes	Surface Condition? (G/P)	Good
			No	Curb Slope (%)	15.0

**Remove & Replace Curb Ramp With Two New Directional Ramps or Equivalent.**
