Access Compliance Report

Public Rights-of-Way

(Curb Ramps)

Intersection ID: 25643	Main Street: WEDDINGTON_RD	Cross Street: WINTERBROOKE_DR	Location: SE
ADA ID: 6AE740E79719	Ramp Type: Perp	Initial Pass/Fail: Fail	Overall Compliance: No
Severity Score: 1.25			
Codes/Mitigation Info/Possible Solution		Field Measurements/Component Compliance

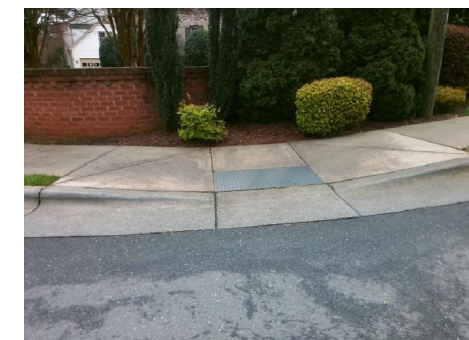
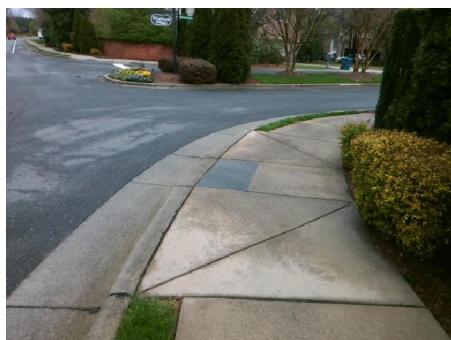
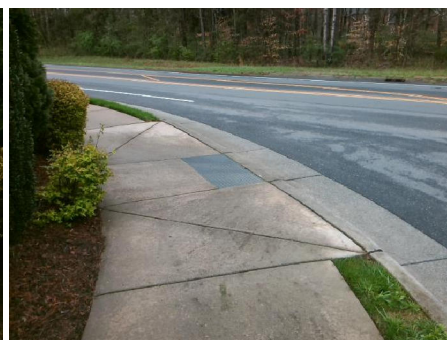
Not Found, R304.5.3

Compliance	Description	Data	Compliance	Description	Data
N/A	Ramp Length (in)	72.0	Yes	Ramp Slope (%)	4.4
Yes	Ramp Width (in)	48.0	No	Ramp XSlope (%)	3.0
N/A	Flare Type LT	N/A	N/A	Flare Type RT	N/A
N/A	Flare Slope LT (%)	N/A	N/A	Flare Slope RT (%)	N/A
N/A	Flare Traversable LT?	N/A	N/A	Flare Traversable RT?	N/A
N/A	Landing Length (in)	N/A	N/A	DWS Provided?	N/A
N/A	Landing Width (in)	N/A	N/A	DWS Contrast?	N/A
N/A	Landing Slope (%)	N/A	N/A	DWS Length (in)	N/A
N/A	Landing X Slope (%)	N/A	N/A	DWS Full Width?	N/A
N/A	Landing Curb? (Y/N)	N/A	N/A	DWS Offset (in)	N/A
N/A	Shared Landing?	N/A			
N/A	Gutter Ponding?	N/A	N/A	Gutter Slope (%)	N/A
N/A	Gutter Lip Ht (in)	N/A	N/A	Gutter X Slope (%)	N/A
N/A	Painted X Walk1?	No	N/A	Painted X Walk2?	N/A
	X Walk 1 Direction	To N		X Walk 2 Direction	N/A
N/A	X Walk 1 Width (in)	N/A	N/A	X Walk 2 Width (in)	N/A
	X Walk 1 Slope (%)	4.3		X Walk 2 Slope (%)	N/A
	X Walk 1 X Slope (%)	0.2		X Walk 2 X Slope (%)	N/A

N/A	Ramp inside XWalk1?	N/A	N/A	Ramp inside XWalk2?	N/A
	Road Slope (%)	N/A	N/A	Clear Space?	N/A
	Road X Slope (%)	N/A	N/A	Clear Space to XWalk (in)	N/A
N/A	Any Obstructions?	N/A	N/A	Storm Grate/Utility Hazard?	N/A
	Obstruction Type			Storm Grate/Utility Type	
		N/A			N/A
			Yes	Surface Condition? (G/P)	Good

Remove & Replace Entire Ramp.
