Access Compliance Report

Public Rights-of-Way

(Curb Ramps)

Intersection ID: 52449	Main Street: TRANQUIL_OAK_PL	Cross Street: PAT_GARRETT_ST	Location: SE
ADA ID: 6AEB76A3A09C	Ramp Type: Directional1	Initial Pass/Fail: Fail	Overall Compliance: No
		Severity Score: 25

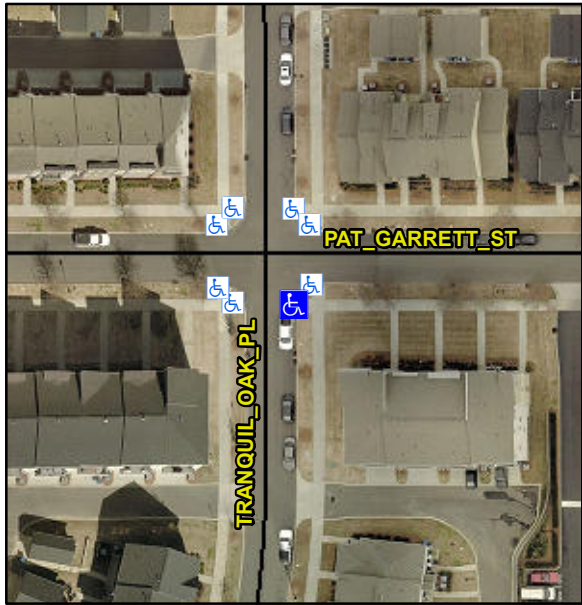
</div> <div>Street 1 Name<div>TRANQUIL OAK PL</div></div> <div>Stop Condition-Street 1<div>StopSign</div></div> <div>Street 2 Name<div>N/A</div></div> <div>Stop Condition-Street 2<div>N/A</div></div>			Possible Solutions:			Compliance			Description			Data		
			Remove & Replace Entire Ramp.			N/A			Ramp Length (in)			82.0		
						Yes			Ramp Width (in)			67.0		
						No			Ramp Slope (%)			12.8		
						Yes			Ramp XSlope (%)			0.2		
						N/A			Flare Type LT			N/A		
						N/A			Flare Slope LT (%)			N/A		
						N/A			Flare Traversable LT?			N/A		
						N/A			Landing Length (in)			0.0		
						N/A			Landing Width (in)			0.0		
						N/A			Landing Slope (%)			0.0		
						N/A			Landing X Slope (%)			0.0		
						N/A			Landing Curb? (Y/N)			N/A		
						N/A			Shared Landing?			N/A		
						N/A			Gutter Ponding?			0.0

N/A			Gutter Lip Ht (in)			1.0		
						N/A			Painted X Walk1?			No		
									X Walk 1 Direction			To W		
									X Walk 1 Width (in)			N/A		
									X Walk 1 Slope (%)			2.1		
									X Walk 1 X Slope (%)			0.7		
						N/A			Ramp inside XWalk1?			N/A		
						N/A			Any Obstructions?			N/A		
									Obstruction Type			Yes		
												N/A		
									N/A					
									N/A					
									N/A					
									N/A					
									N/A					
									N/A					
									N/A					
									N/A					
									N/A					
									N/A					
									N/A					
									N/A					
									N/A					
									N/A					
									N/A					
									N/A					
									N/A					
									N/A					
									N/A					
									N/A					
									N/A					
									N/A					
									N/A					
									N/A					
									N/A					
									N/A					
									N/A					
									N/A					
									N/A					
									N/A					
									N/A					
									N/A					
									N/A

Remove & Replace Entire Ramp.

R304.2.2
