Access Compliance Report

Public Rights-of-Way

(Curb Ramps)

Intersection ID: N/A	Main Street: PROVIDENCE_RD	Cross Street: N/A	Location: SW
ADA ID: 6AEC021B05E1	Ramp Type: MedianPerp	Initial Pass/Fail: Fail	Overall Compliance: No
		Severity Score: 13.75

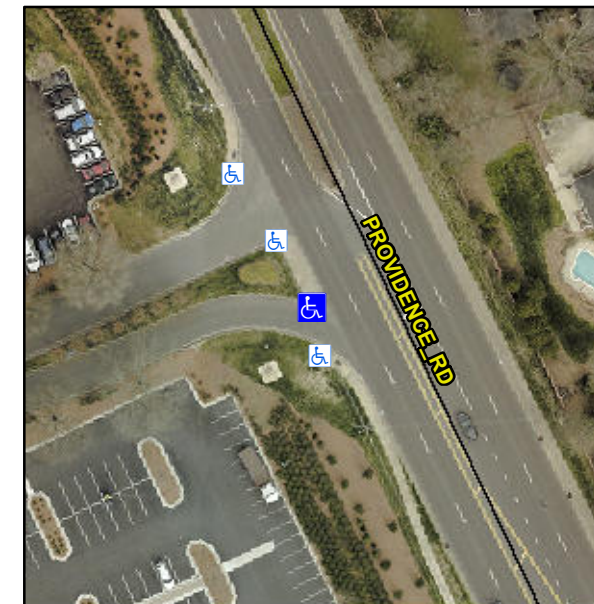
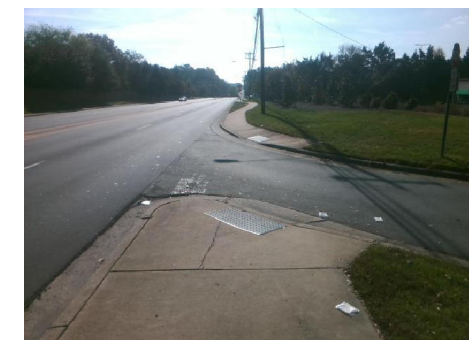
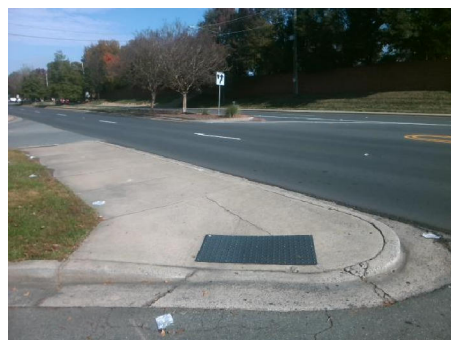
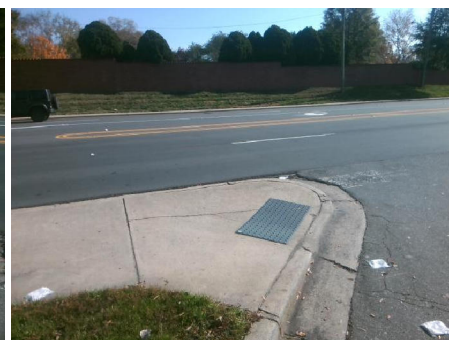
Not Found, R304.2.2, R304.5.3

Compliance	Description	Data	Compliance	Description	Data
N/A	Ramp Length (in)	48.0	No	Ramp Slope (%)	8.7
Yes	Ramp Width (in)	48.0	No	Ramp XSlope (%)	3.7
N/A	Flare Type LT	N/A	N/A	Flare Type RT	N/A
N/A	Flare Slope LT (%)	N/A	N/A	Flare Slope RT (%)	N/A
N/A	Flare Traversable LT?	N/A	N/A	Flare Traversable RT?	N/A
N/A	Landing Length (in)	N/A	N/A	DWS Provided?	N/A
N/A	Landing Width (in)	N/A	N/A	DWS Contrast?	N/A
N/A	Landing Slope (%)	N/A	N/A	DWS Length (in)	N/A
N/A	Landing X Slope (%)	N/A	N/A	DWS Full Width?	N/A
N/A	Landing Curb? (Y/N)	N/A	N/A	DWS Offset (in)	N/A
N/A	Shared Landing?	N/A			
N/A	Gutter Ponding?	N/A	N/A	Gutter Slope (%)	N/A
N/A	Gutter Lip Ht (in)	N/A	N/A	Gutter X Slope (%)	N/A
N/A	Painted X Walk1?	No	N/A	Painted X Walk2?	N/A
	X Walk 1 Direction	To SE		X Walk 2 Direction	N/A
N/A	X Walk 1 Width (in)	N/A	N/A	X Walk 2 Width (in)	N/A
	X Walk 1 Slope (%)	5.5		X Walk 2 Slope (%)	N/A
	X Walk 1 X Slope (%)	2.2		X Walk 2 X Slope (%)	N/A

N/A	Ramp inside XWalk1?	N/A	N/A	Ramp inside XWalk2?	N/A
	Road Slope (%)	N/A	N/A	Clear Space?	N/A
	Road X Slope (%)	N/A	N/A	Clear Space to XWalk (in)	N/A
N/A	Any Obstructions?	N/A	N/A	Storm Grate/Utility Hazard?	N/A
	Obstruction Type			Storm Grate/Utility Type	
		N/A			N/A
			Yes	Surface Condition? (G/P)	Good

Remove & Replace Entire Ramp.
