# Access Compliance Report

## Public Rights-of-Way

### (Curb Ramps)

Intersection ID: 19505	Main Street: BADENOC_H_CT	Cross Street: GRETNA_GREEN_DR	Location: SW
ADA ID: 6AEEC1681E5A	Ramp Type: Directional1	Initial Pass/Fail: Fail	Overall Compliance: No
Severity Score: 1.25			
Codes/Mitigation Info/Possible Solution		Field Measurements/Component Compliance

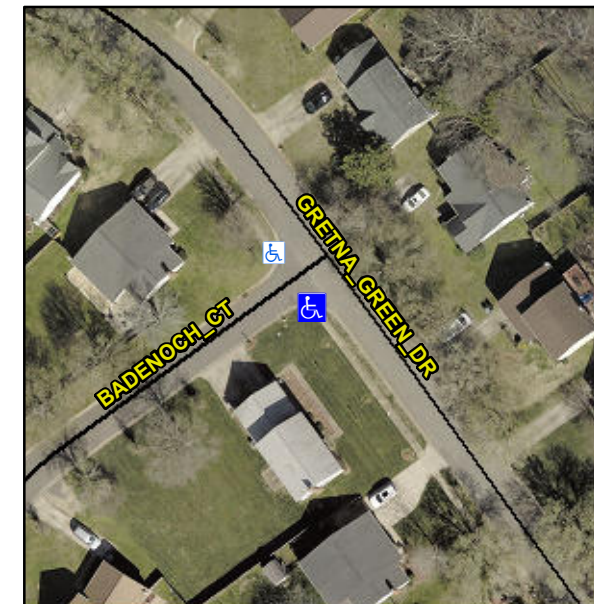
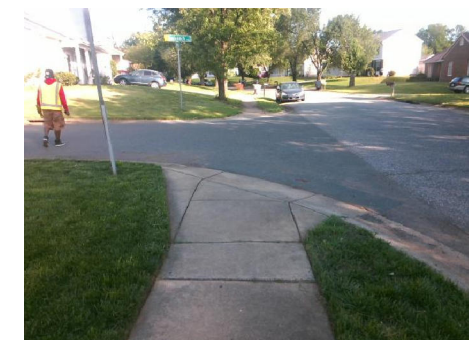
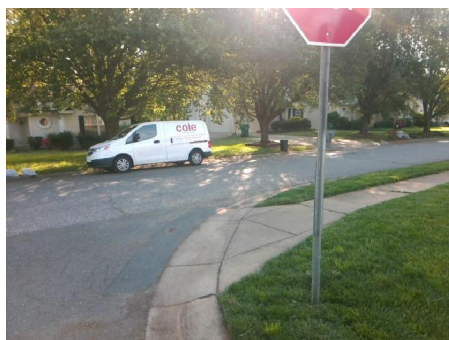
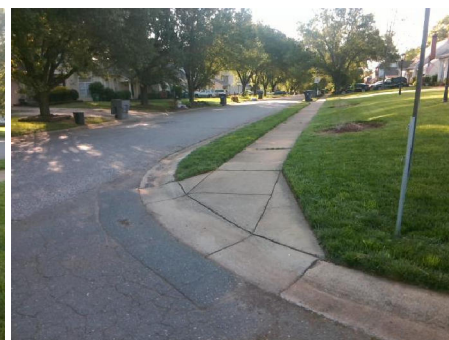
Compliance	Description	Data	Compliance	Description	Data
N/A	Ramp Length (in)	96.0	N/A	Grade Break?	N/A
Yes	Ramp Width (in)	48.0	N/A	Grade Break Slope (%)	0.0
Yes	Ramp Slope (%)	5.7	N/A	Grade Break XSlope (%)	0.0
No	Ramp XSlope (%)	2.1			
N/A	Flare Type LT	N/A	N/A	Flare Type RT	N/A
N/A	Flare Slope LT (%)	N/A	N/A	Flare Slope RT (%)	0.0
N/A	Flare Traversable LT?	N/A	N/A	Flare Traversable RT?	N/A
N/A	Landing Length (in)	0.0	N/A	DWS Provided?	N/A
N/A	Landing Width (in)	0.0	N/A	DWS Contrast?	N/A
N/A	Landing Slope (%)	0.0	N/A	DWS Length (in)	N/A
N/A	Landing X Slope (%)	0.0	N/A	DWS Full Width?	N/A
N/A	Landing Curb? (Y/N)	N/A	N/A	DWS Offset LT (in)	N/A
N/A	Shared Landing?	N/A	N/A	DWS Offset RT (in)	N/A
N/A	Gutter Ponding?	0.0	N/A	Gutter Slope (%)	N/A
N/A	Gutter Lip Ht (in)	0.0	N/A	Gutter X Slope (%)	N/A
N/A	Painted X Walk1?	No		Road Slope (%)	0.4
	X Walk 1 Direction	To NW		Road X Slope (%)	3.7
	X Walk 1 Width (in)	N/A		Clear Space?	N/A

X Walk 1 Slope (%)	0.4	N/A	Clear Space to XWalk (in)	N/A
	X Walk 1 X Slope (%)	3.7	N/A	Storm Grate/Utility Hazard?	N/A
N/A	Ramp inside XWalk1?	N/A		Storm Grate/Utility Type	
N/A	Any Obstructions?	N/A			N/A
	Obstruction Type		Yes	Surface Condition? (G/P)	Good
			N/A	Curb Slope (%)	2.0

Possible Solutions:

**Remove & Replace Entire Ramp.**

PROW/ADA:

**R304.5.3**
