Access Compliance Report

Public Rights-of-Way

(Curb Ramps)

Intersection ID: 17696	Main Street: DENON_HILLS_DR	Cross Street: E W T HARRIS BV	Location: NW
ADA ID: 6AEF80269FCB	Ramp Type: PerpDiag	Initial Pass/Fail: Fail	Overall Compliance: No
		Severity Score: 10

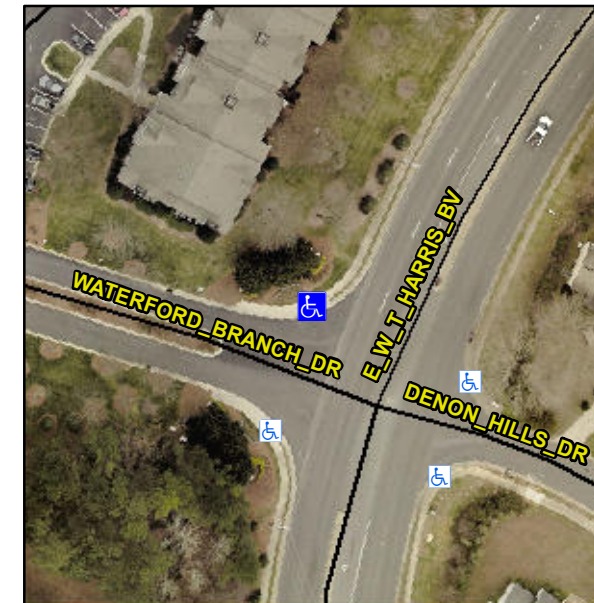
Not Found, R304.5.1, R304.5.3

Compliance	Description	Data	Compliance	Description	Data
N/A	Ramp Length (in)	26.5	Yes	Ramp Slope (%)	8.0
No	Ramp Width (in)	45.5	No	Ramp XSlope (%)	3.2
N/A	Flare Type LT	N/A	N/A	Flare Type RT	N/A
N/A	Flare Slope LT (%)	N/A	N/A	Flare Slope RT (%)	N/A
N/A	Flare Traversable LT?	N/A	N/A	Flare Traversable RT?	N/A
N/A	Landing Length (in)	N/A	N/A	DWS Provided?	N/A
N/A	Landing Width (in)	N/A	N/A	DWS Contrast?	N/A
N/A	Landing Slope (%)	N/A	N/A	DWS Length (in)	N/A
N/A	Landing X Slope (%)	N/A	N/A	DWS Full Width?	N/A
N/A	Landing Curb? (Y/N)	N/A	N/A	DWS Offset (in)	N/A
N/A	Shared Landing?	N/A			
N/A	Gutter Ponding?	N/A	N/A	Gutter Slope (%)	N/A
N/A	Gutter Lip Ht (in)	N/A	N/A	Gutter X Slope (%)	N/A
N/A	Painted X Walk1?	No	N/A	Painted X Walk2?	No
	X Walk 1 Direction	To SW		X Walk 2 Direction	To SE
N/A	X Walk 1 Width (in)	N/A	N/A	X Walk 2 Width (in)	N/A
	X Walk 1 Slope (%)	1.4		X Walk 2 Slope (%)	4.4
	X Walk 1 X Slope (%)	3.3		X Walk 2 X Slope (%)	1.4

N/A	Ramp inside XWalk1?	N/A	N/A	Ramp inside XWalk2?	N/A
	Road Slope (%)	1.9	N/A	Clear Space?	N/A
	Road X Slope (%)	3.9	N/A	Clear Space to XWalk (in)	N/A
N/A	Any Obstructions?	N/A	N/A	Storm Grate/Utility Hazard?	N/A
	Obstruction Type			Storm Grate/Utility Type	
		N/A			N/A
			Yes	Surface Condition? (G/P)	Good

Remove & Replace Curb Ramp With Two New Directional Ramps or Equivalent.

Total Cost: \$ 3200.00
