# Access Compliance Report

## Public Rights-of-Way

### (Curb Ramps)

Intersection ID: 30337	Main Street: DULIN_CREEK_BV	Cross Street: GOLD_PAN_RD	Location: NE
ADA ID: 6AF7FA4E7A68	Ramp Type: PerpDiag	Initial Pass/Fail: Fail	Overall Compliance: No
Severity Score: 33.75			
Codes/Mitigation Info/Possible Solution		Field Measurements/Component Compliance

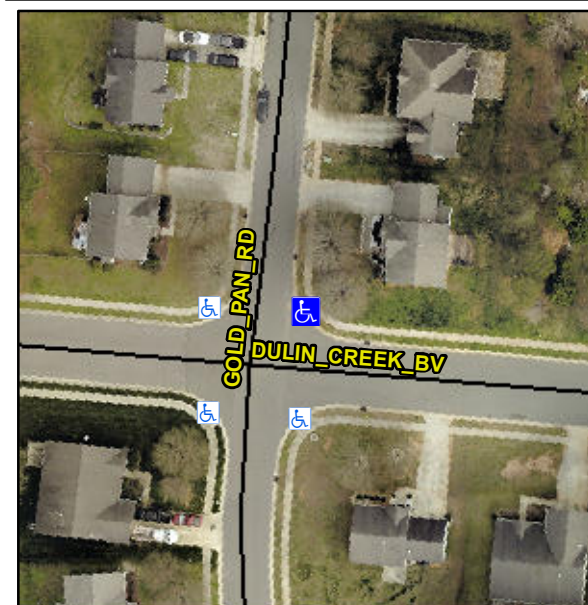
**Not Found, R304.5.1, R304.2.2**

Compliance	Description	Data	Compliance	Description	Data
N/A	Ramp Length (in)	47.5	No	Ramp Slope (%)	15.7
No	Ramp Width (in)	47.0	Yes	Ramp XSlope (%)	0.5
N/A	Flare Type LT	N/A	N/A	Flare Type RT	N/A
N/A	Flare Slope LT (%)	N/A	N/A	Flare Slope RT (%)	N/A
N/A	Flare Traversable LT?	N/A	N/A	Flare Traversable RT?	N/A
N/A	Landing Length (in)	N/A	N/A	DWS Provided?	N/A
N/A	Landing Width (in)	N/A	N/A	DWS Contrast?	N/A
N/A	Landing Slope (%)	N/A	N/A	DWS Length (in)	N/A
N/A	Landing X Slope (%)	N/A	N/A	DWS Full Width?	N/A
N/A	Landing Curb? (Y/N)	N/A	N/A	DWS Offset (in)	N/A
N/A	Shared Landing?	N/A			
N/A	Gutter Ponding?	N/A	N/A	Gutter Slope (%)	N/A
N/A	Gutter Lip Ht (in)	0.5	N/A	Gutter X Slope (%)	N/A
N/A	Painted X Walk1?	No	N/A	Painted X Walk2?	No
	X Walk 1 Direction	To W		X Walk 2 Direction	To S
N/A	X Walk 1 Width (in)	N/A	N/A	X Walk 2 Width (in)	N/A
	X Walk 1 Slope (%)	0.6		X Walk 2 Slope (%)	0.7
	X Walk 1 X Slope (%)	1.7		X Walk 2 X Slope (%)	4.0

N/A	Ramp inside XWalk1?	N/A	N/A	Ramp inside XWalk2?	N/A
	Road Slope (%)	1.2	N/A	Clear Space?	N/A
	Road X Slope (%)	2.3	N/A	Clear Space to XWalk (in)	N/A
N/A	Any Obstructions?	N/A	N/A	Storm Grate/Utility Hazard?	N/A
	Obstruction Type			Storm Grate/Utility Type	
		N/A			N/A
		Yes		Surface Condition? (G/P)	Good

**Remove & Replace Curb Ramp With Two New Directional Ramps or Equivalent.**
