Access Compliance Report

Public Rights-of-Way

(Curb Ramps)

Intersection ID: 7129	Main Street: DAWNSHIRE_AV	Cross Street: NORTHBROOK_DR	Location: NW
ADA ID: 6AFA8A11CD54	Ramp Type: Perp	Initial Pass/Fail: Fail	Overall Compliance: No
		Severity Score: 12.5

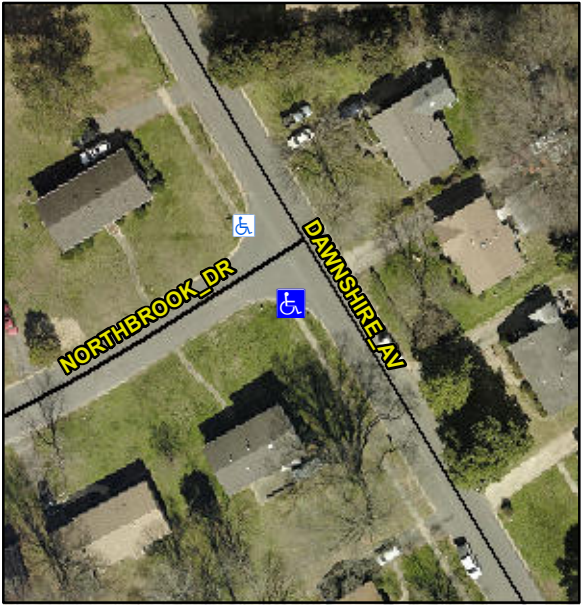
Possible Solutions:	Compliance	Description	Data	Compliance	Description	Data
	Remove & Replace Entire Ramp.	N/A	Ramp Length (in)	38.0	Yes	Ramp Slope (%)	6.1
		Yes	Ramp Width (in)	48.0	No	Ramp XSlope (%)	6.8
		N/A	Flare Type LT	N/A	N/A	Flare Type RT	N/A
		N/A	Flare Slope LT (%)	N/A	N/A	Flare Slope RT (%)	N/A
		N/A	Flare Traversable LT?	N/A	N/A	Flare Traversable RT?	N/A
		N/A	Landing Length (in)	N/A	N/A	DWS Provided?	N/A
		N/A	Landing Width (in)	N/A	N/A	DWS Contrast?	N/A
		N/A	Landing Slope (%)	N/A	N/A	DWS Length (in)	N/A
		N/A	Landing X Slope (%)	N/A	N/A	DWS Full Width?	N/A
		N/A	Landing Curb? (Y/N)	N/A	N/A	DWS Offset (in)	N/A
		N/A	Shared Landing?	N/A			
		N/A	Gutter Ponding?	N/A	N/A	Gutter Slope (%)	N/A
		N/A	Gutter Lip Ht (in)	N/A	N/A	Gutter X Slope (%)	N/A
		N/A	Painted X Walk1?	No	N/A	Painted X Walk2?	N/A
			X Walk 1 Direction	To NW		X Walk 2 Direction	N/A

N/A	X Walk 1 Width (in)	N/A	N/A	X Walk 2 Width (in)	N/A
			X Walk 1 Slope (%)	7.3		X Walk 2 Slope (%)	N/A
			X Walk 1 X Slope (%)	3.2		X Walk 2 X Slope (%)	N/A
		N/A	Ramp inside XWalk1?	N/A	N/A	Ramp inside XWalk2?	N/A
<p>Surveyor Notes:</p> <p>N/A</p> <p>PROW/ADA:</p> <p>Not Found, R304.5.3</p>			Road Slope (%)	N/A	N/A	Clear Space?	N/A
			Road X Slope (%)	N/A	N/A	Clear Space to XWalk (in)	N/A
		N/A	Any Obstructions?	N/A	N/A	Storm Grate/Utility Hazard?	N/A
			Obstruction Type			Storm Grate/Utility Type	
				N/A			N/A
					Yes	Surface Condition? (G/P)	Good
Total Cost:		\$	1850.00
