Access Compliance Report

Public Rights-of-Way

(Curb Ramps)

Intersection ID: 8938	Main Street: NORRIS_AV	Cross Street: NEWLAND_RD	Location: NW
ADA ID: 6B1056DAA0E4	Ramp Type: Para	Initial Pass/Fail: Fail	Overall Compliance: No
		Severity Score: 1.25

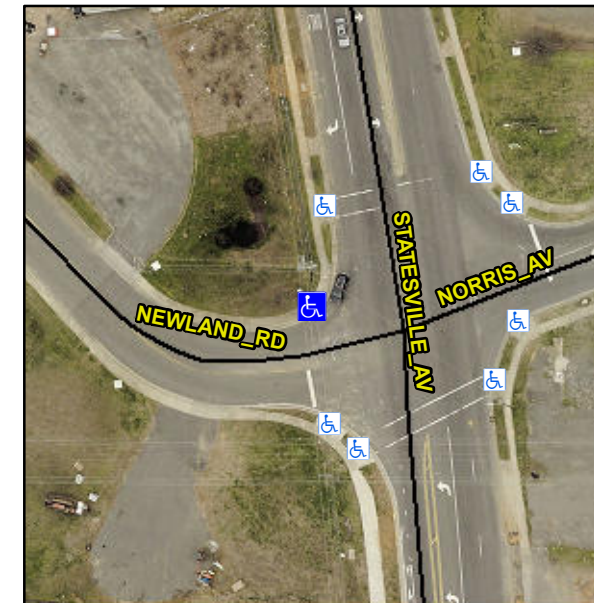
DAMAGED DWS

R304.5.3

Compliance	Description	Data	Compliance	Description	Data
N/A	Ramp Length LT (in)	65.0	N/A	Ramp Length RT (in)	56.0
Yes	Ramp Width LT (in)	60.0	Yes	Ramp Width RT (in)	60.0
Yes	Ramp Slope LT (%)	6.9	Yes	Ramp Slope RT (%)	8.0
Yes	Ramp XSlope LT (%)	1.7	No	Ramp XSlope RT (%)	2.6
N/A	Landing Length (in)	N/A	N/A	DWS Provided?	N/A
N/A	Landing Width (in)	N/A	N/A	DWS Contrast?	N/A
N/A	Landing Slope (%)	N/A	N/A	DWS Length (in)	N/A
N/A	Landing X Slope (%)	N/A	N/A	DWS Full Width?	N/A
N/A	Landing Curb? (Y/N)	N/A	N/A	DWS Offset (in)	N/A
N/A	Shared Landing?	N/A			
N/A	Gutter Ponding?	N/A	N/A	Gutter Slope (%)	N/A
N/A	Gutter Lip Ht (in)	N/A	N/A	Gutter X Slope (%)	N/A
N/A	Painted X Walk1?	No	N/A	Painted X Walk2?	N/A
	X Walk 1 Direction	To SE		X Walk 2 Direction	N/A
N/A	X Walk 1 Width (in)	N/A	N/A	X Walk 2 Width (in)	N/A
	X Walk 1 Slope (%)	1.5		X Walk 2 Slope (%)	N/A
	X Walk 1 X Slope (%)	0.2		X Walk 2 X Slope (%)	N/A
N/A	Ramp inside XWalk1?	N/A	N/A	Ramp inside XWalk2?	N/A

Road Slope (%)	N/A	N/A	Clear Space?	N/A
	Road X Slope (%)	N/A	N/A	Clear Space to XWalk (in)	N/A
N/A	Any Obstructions?	N/A	N/A	Storm Grate/Utility Hazard?	N/A
	Obstruction Type			Storm Grate/Utility Type	
		N/A			N/A
			Yes	Surface Condition? (G/P)	Good
			N/A	Curb Slope (%)	8.6

Remove & Replace Entire Ramp.
