Access Compliance Report Public Rights-of-Way (Curb Ramps)

Intersection ID: 6044 Main Street: GRENELEFE VILLAGE RD Cross Street: HOSTA DR Location: W Initial Pass/Fail: Fail **Overall Compliance: No Severity Score:** 12.5 ADA ID: 6B135B186182 Ramp Type: Perp

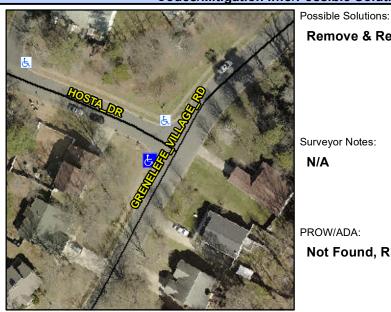
Total Cost: 1850.00 Compliance Description Data Compliance Description Data Yes Ramp Slope (%) N/A Ramp Length (in) 39.0 6.4 No Ramp XSlope (%) Yes Ramp Width (in) 48.0 5.7 N/A Flare Type LT N/A N/A Flare Type RT N/A N/A N/A N/A Flare Slope RT (%) N/A Flare Slope LT (%) N/A Flare Traversable LT? N/A N/A Flare Traversable RT? N/A N/A N/A N/A **DWS Provided?** N/A Landing Length (in) N/A Landing Width (in) N/A N/A **DWS Contrast?** N/A N/A N/A N/A Landing Slope (%) DWS Length (in) N/A N/A Landing X Slope (%) N/A N/A DWS Full Width? N/A N/A Landing Curb? (Y/N) N/A N/A DWS Offset (in) N/A N/A N/A Shared Landing? N/A **Gutter Ponding?** N/A N/A Gutter Slope (%) N/A N/A Gutter Lip Ht (in) N/A N/A Gutter X Slope (%) N/A N/A Painted X Walk1? No N/A Painted X Walk2? N/A X Walk 1 Direction To NE X Walk 2 Direction N/A N/A N/A X Walk 1 Width (in) N/A X Walk 2 Width (in) N/A X Walk 1 Slope (%) 2.3 X Walk 2 Slope (%) N/A X Walk 1 X Slope (%) 2.7 X Walk 2 X Slope (%) N/A N/A N/A N/A Ramp inside XWalk2? Ramp inside XWalk1? N/A Road Slope (%) N/A N/A Clear Space? N/A Road X Slope (%) N/A N/A Clear Space to XWalk (in) N/A N/A N/A Any Obstructions? N/A Storm Grate/Utility Hazard? N/A

Remove & Replace Entire Ramp. Surveyor Notes: N/A PROW/ADA: Not Found, R304.5.3
