# Access Compliance Report

## Public Rights-of-Way

### (Curb Ramps)

| Intersection ID: 4159 | Main Street: COLVARD_CR | Cross Street: COLVARD_PARK_WY | Location: NE |

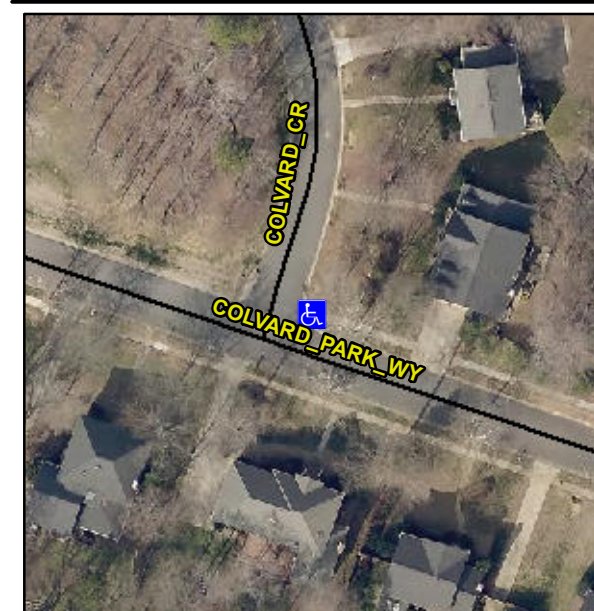
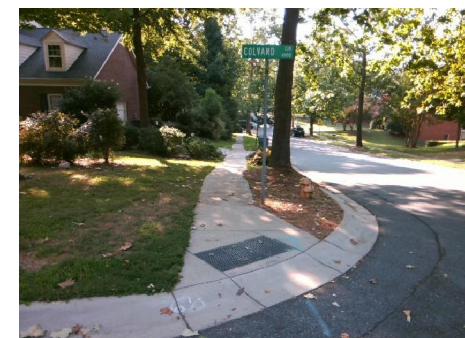
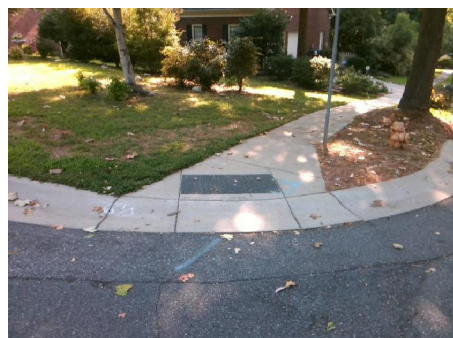
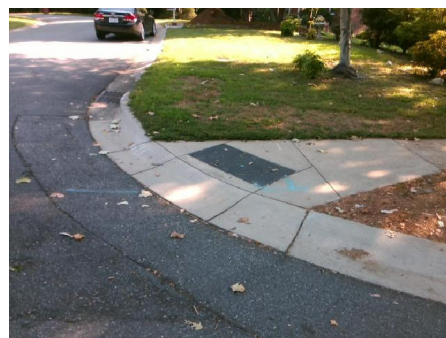
**Not Found, R304.5.3, R304.2.1, R304.2.2-Perp, R304.3.2-Para, R305.1.4, R305.2, R302.7.2**

| Compliance | Description | Data | Compliance | Description | Data |
|---|---|---|---|---|---|
| Yes | Ramp Width (in) | 48.0 | No | BlendTrans XSlope (%) | 4.7 |
| No | Landing Length (in) | 46.0 | Yes | DWS Provided? | Yes |
| No | Landing Width (in) | 37.0 | Yes | DWS Contrast? | Yes |
| No | Landing Slope (%) | 6.1 | Yes | DWS Length (in) | 24.0 |
| Yes | Landing X Slope (%) | 0.7 | No | DWS Full Width? | No |
| N/A | Landing Curb? (Y/N) | No | No | DWS Offset (in) | 6.5 |
| No | Gutter Lip Ht (in) | 0.5 | No | Gutter X Slope (%) | 4.6 |

**Remove & Replace Curb Ramp With Two New Directional Ramps or Equivalent. Remove & Replace Gutter.**
