Access Compliance Report

Public Rights-of-Way

(Curb Ramps)

| Intersection ID: 29271 | Main Street: IRON_BRIGADE_LN | Cross Street: LAKOTA_CT | Location: S |

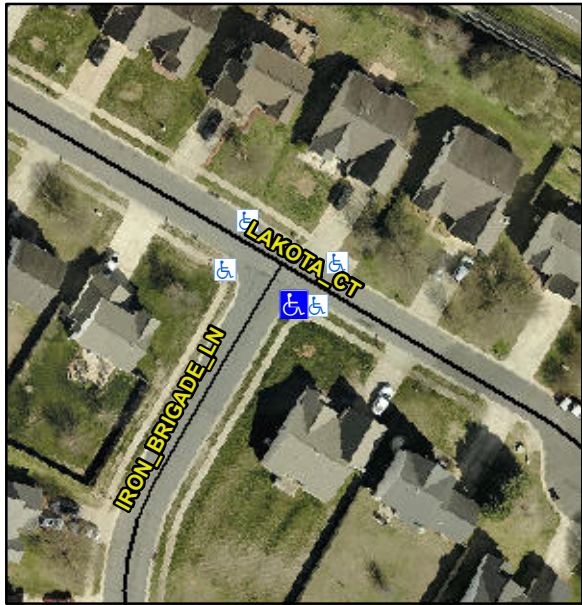
| Severity Score: 58.75 | | | |

R304.5.1, R304.2.2, R304.5.3

| Compliance | Description | Data | Compliance | Description | Data |
|---|---|---|---|---|---|
| N/A | Ramp Length (in) | 45.0 | No | Ramp Slope (%) | 13.7 |
| No | Ramp Width (in) | 43.0 | No | Ramp XSlope (%) | 8.7 |

Possible Solutions:

Remove & Replace Curb Ramp With Two New Directional Ramps or Equivalent.

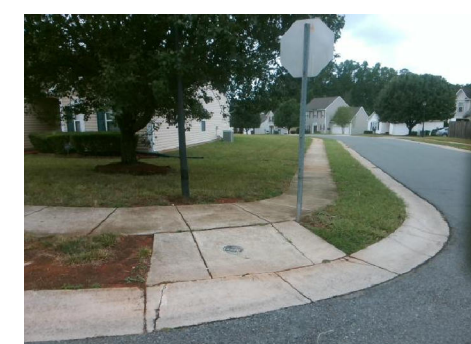
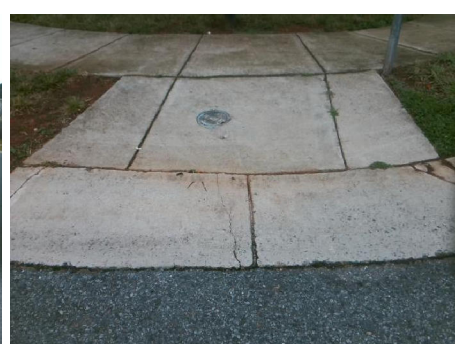
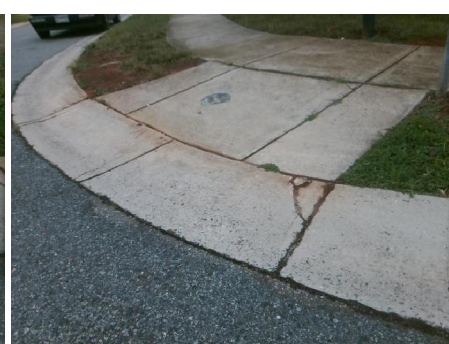
| ADA ID: 6B24EC24E218 | Ramp Type: PerpDiag | Initial Pass/Fail: Fail | Overall Compliance: No |
