## Access Compliance Report Public Rights-of-Way (Curb Ramps)

Intersection ID: 10431Main Street: ASHLEY\_RDCross Street: SCOTT\_FUTRELL\_DRLocation: SWADA ID: 6B2CF5629E43Ramp Type: PerpInitial Pass/Fail: FailOverall Compliance: NoSeverity Score: 12.5

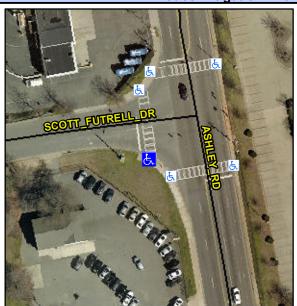
Possible Solution		Field Measurements/Component Compliance					
Possible Solutions:			Compliance Description		Data	Compliance Description	
Remove & Replace Entire F	Ramp.		N/A	Ramp Length (in)	83.0	No	Ramp Slope (%)

•	•		Yes	Ramp Width (in)	48.0	Yes	Ramp XSlope (%)
			N/A	Flare Type LT	N/A	N/A	Flare Type RT
			N/A	Flare Slope LT (%)	N/A	N/A	Flare Slope RT (%)
			N/A	Flare Traversable LT?	N/A	N/A	Flare Traversable RT?
			N/A	Landing Length (in)	N/A	N/A	DWS Provided?
Surveyor Notes:			N/A	Landing Width (in)	N/A	N/A	DWS Contrast?
N/A			N/A	Landing Slope (%)	N/A	N/A	DWS Length (in)
			N/A	Landing X Slope (%)	N/A	N/A	DWS Full Width?
			N/A	Landing Curb? (Y/N)	N/A	N/A	DWS Offset (in)
			N/A	Shared Landing?	N/A		
PROW/ADA:			N/A	Gutter Ponding?	N/A	N/A	Gutter Slope (%)
Not Found, R304.2.2			N/A	Gutter Lip Ht (in)	N/A	N/A	Gutter X Slope (%)
			N/A	Painted X Walk1?	Yes	N/A	Painted X Walk2?
				X Walk 1 Direction	To N		X Walk 2 Direction
			N/A	X Walk 1 Width (in)	114.0	N/A	X Walk 2 Width (in)
				X Walk 1 Slope (%)	1.6		X Walk 2 Slope (%)
				X Walk 1 X Slope (%)	1.3		X Walk 2 X Slope (%)
			N/A	Ramp inside XWalk1?	Yes	N/A	Ramp inside XWalk2?
